Subject : Kereste Yüğü Tahliyesinde Ölümle Sonuçlanan Kaza Raporu Hk..

**Sirküler No: 161 /2018**

Graig Rotterdam isimli dökme yük gemisinde

Yük tahliyesi esnasında meydana gelen ölümlü kaza raporu.

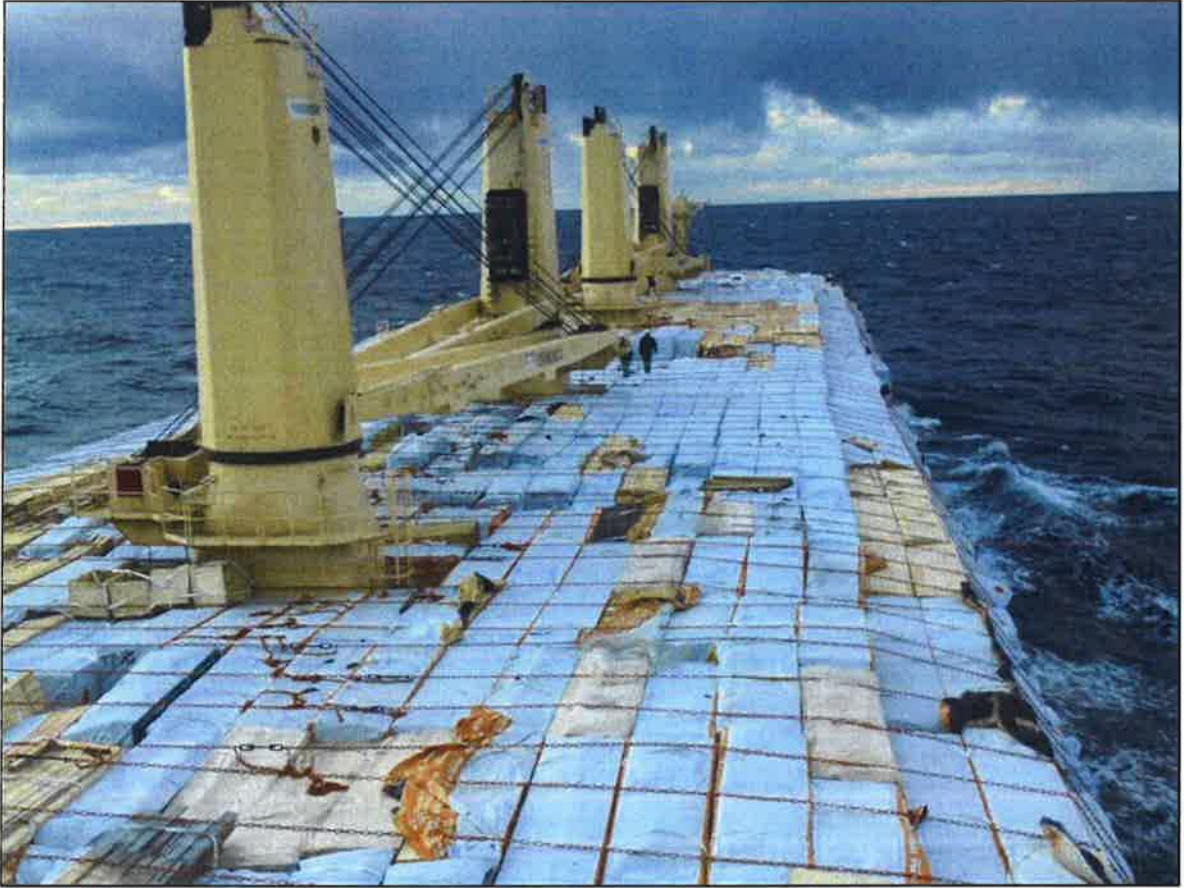
**Resim 2:** Graig Rotterdam gemisinin üzerinden bağlanmış güverte üstü kereste yükü ile seyirde.

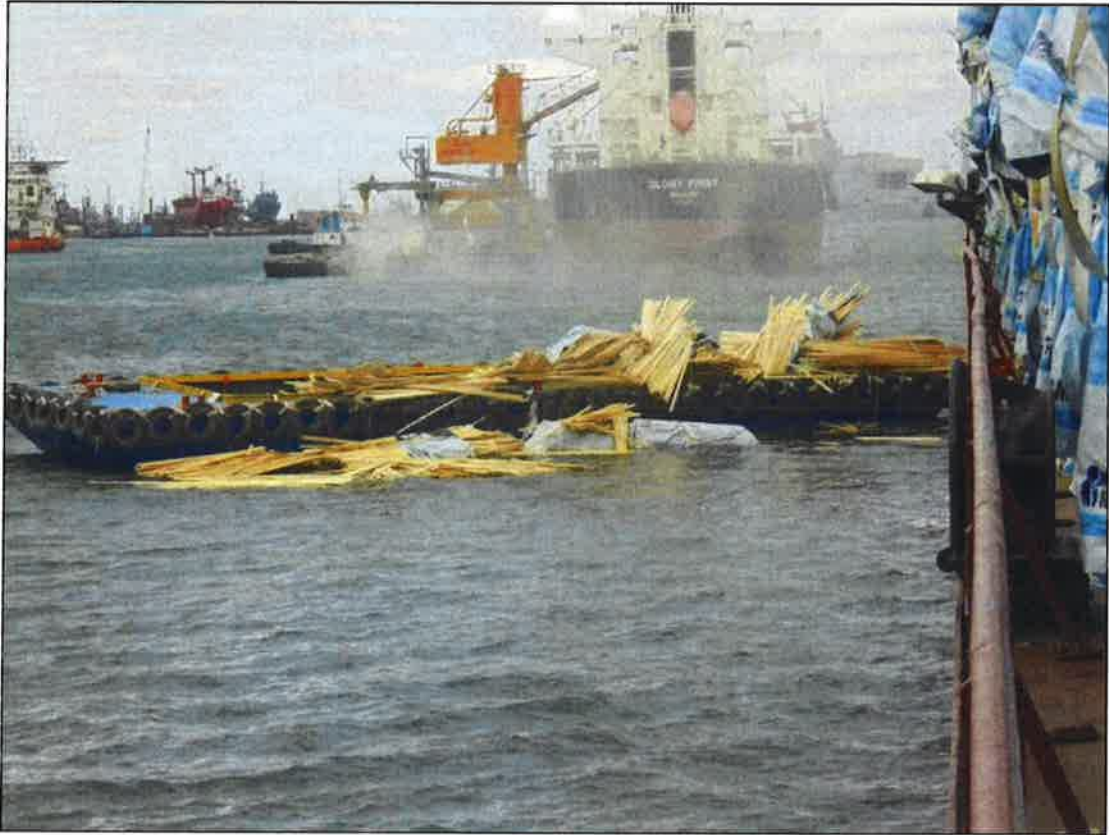
1 no'lu ambar kapağı üzerindeki paketli kereste yığınının iskele tarafındaki yaklaşık 20 paketin bir kısmı denize, geri kalanı da Graig Rotterdam gemisinin iskele baş omuzluğunda aborda olmuş barcın üzerine düştü. (Resim 4) Olay esnasında barçta mürettebat bulunmuyordu, sadece öncesinde yüklenmiş olan kereste yükü vardı.

**Resim 4:** Yükün kayarak iskele barcın üzerine düşme anının hemen sonrası

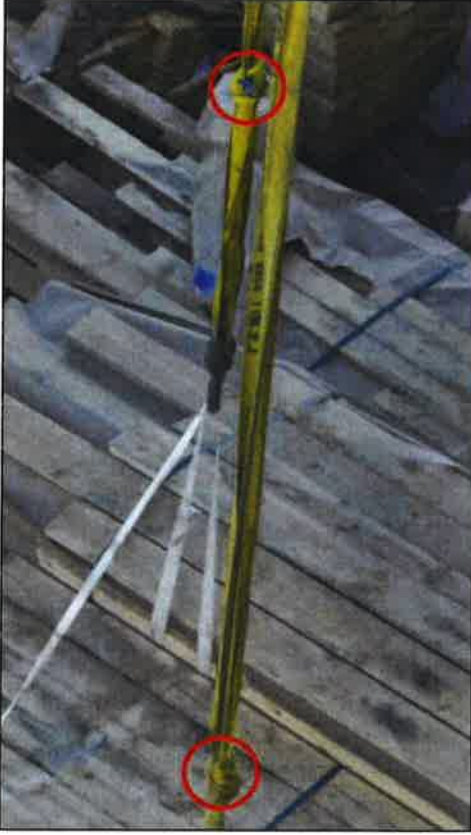
- Yükün kaldırılması için düğümlü yük sapanları (**Resim 5**) ve kanca olarak harbisiz kilitlerin (**Resim 6**) kullanıldığı,
- Güverte yük yığınlarının kenarlarından yüründüğü,
- Tahliye işlerinde görevli mürettebat dışı personelin Kişisel Koruyucu Ekipmanları giymediği, (**Resim 7**)
- Paketli yüklerin denize ve güverteye düşürüldüğü (**Resim 7**),

**Resim 5 :** Dügümlü yük sapanı

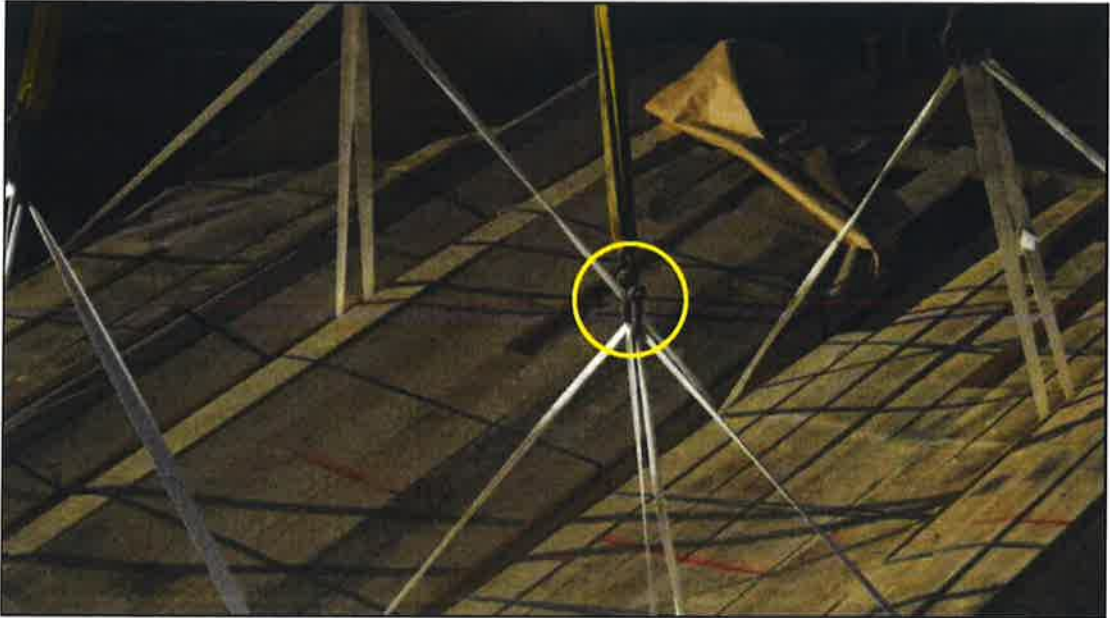
**Resim 6:** Yük kancası olarak kullanılan harbisiz kilit

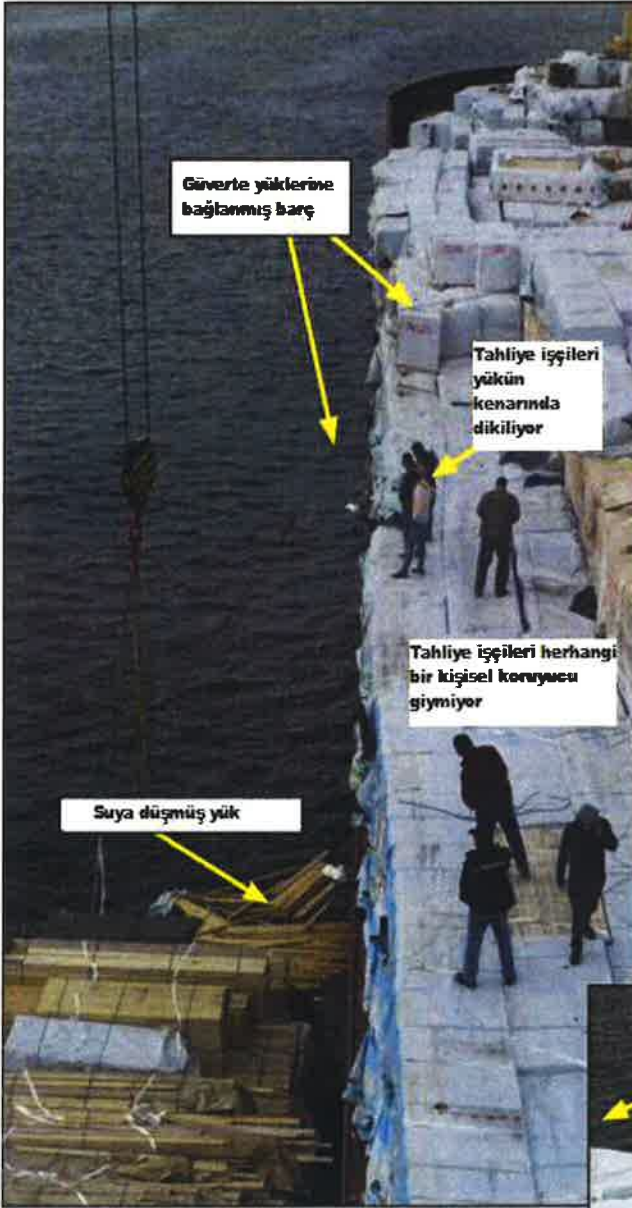
- Güverte yük yığınlarına bağlanmış barç (Resim 7,8 ve 9)
- Güverte yığınları üzerindeyken sigara içilmesi,
- Barçtan gemiye tırmanarak ve kreynele kaldırılarak erişim sağlandığı,

**Resim 7 : Tahliyeciler çalışanların hatalı uygulamaları**

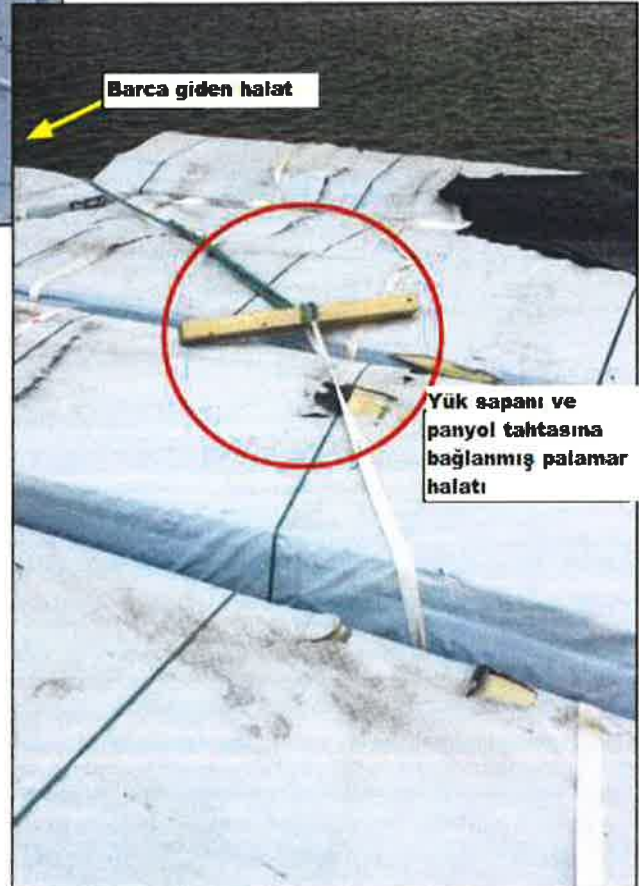
**Resim 8 : Yük yığınına ilştirilmiş palamar halatı**

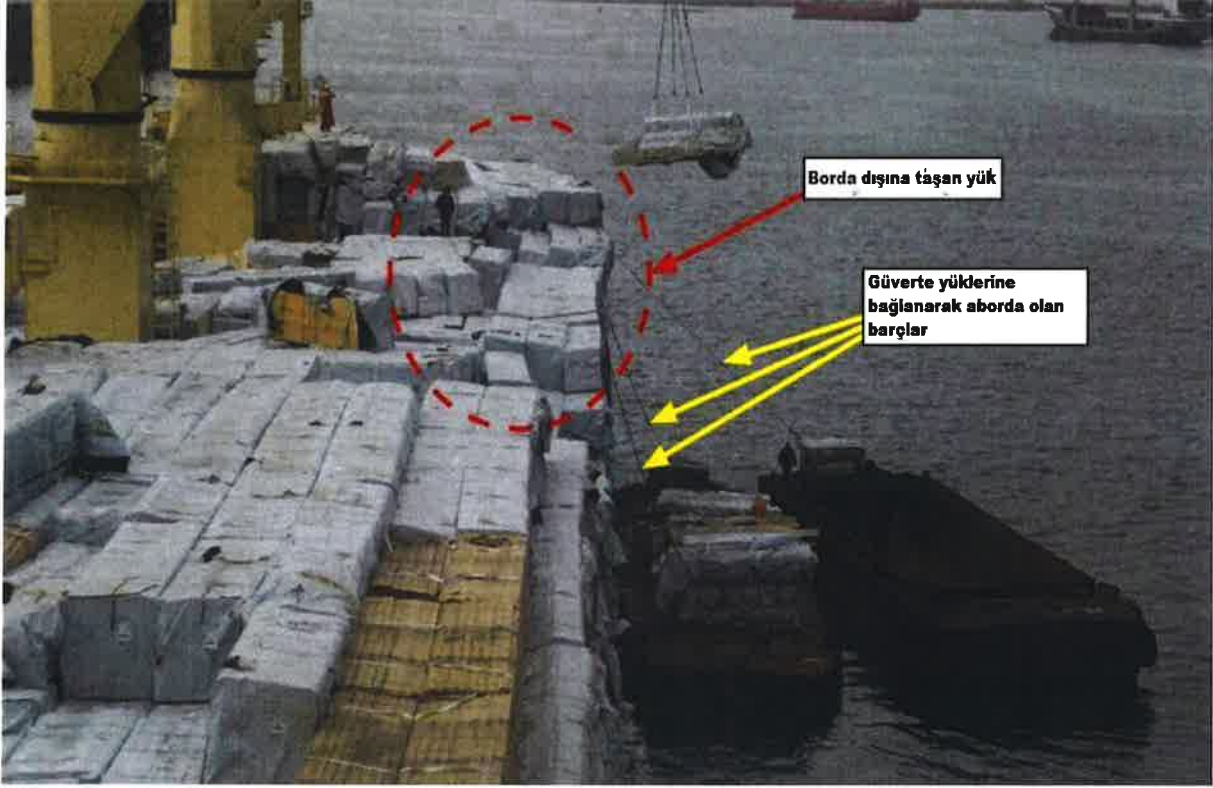
Resim 9: Baş taraftaki yükün borda dışına taşması

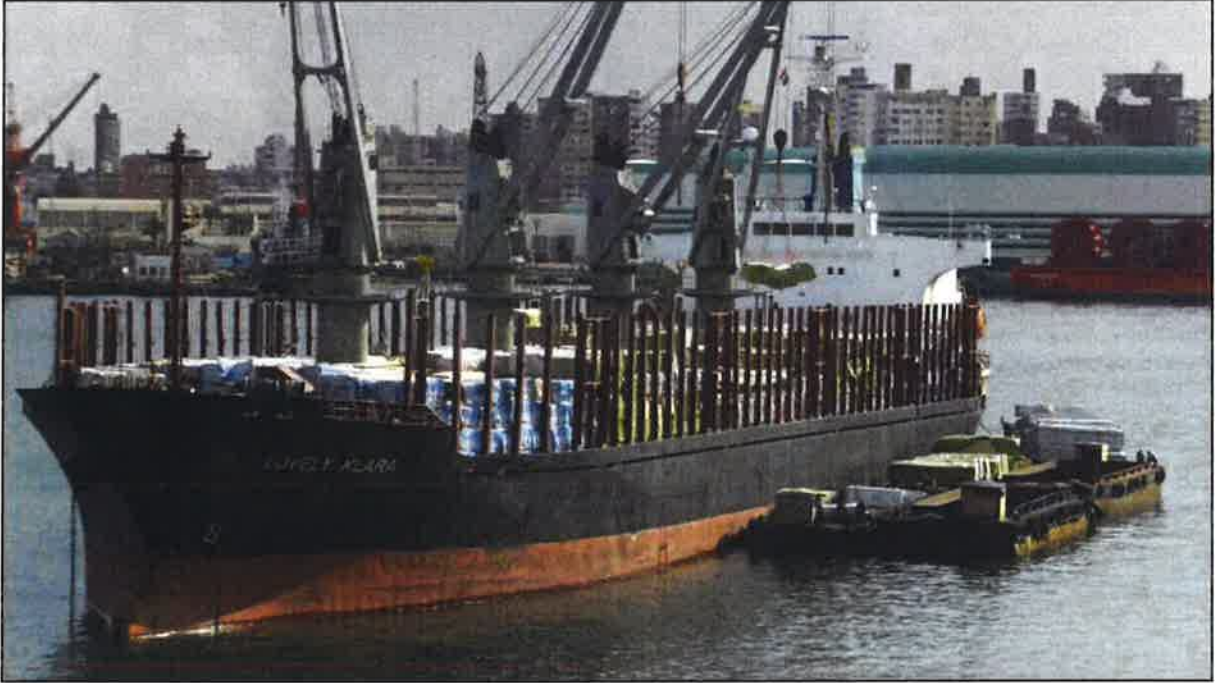
Buna karşın babadalyalar donatılsaydı, Graig Rotterdam gemisinin Mısır'ın İskenderiye Limanında yüz yüze kaldığı olaydaki gibi bir durumla karşı karşıya kalınmaz, tahliye için yükün emniyet bağlarının çözülmesi sonrasında çökmesinden kaçınılabilirdi. Öte yandan kazanın meydana geldiği anda aynı terminalde paketli kereste yükü tahliyesi yapan iki gemi daha vardı ve her ikisi de çelik babadalyalarla donatılmıştı (**Resim 10**).

**Resim 10** : Aynı demir sahasında paketli kereste yükü tahliyesi yapan, çelik babadalya donanımlı bir gemi.

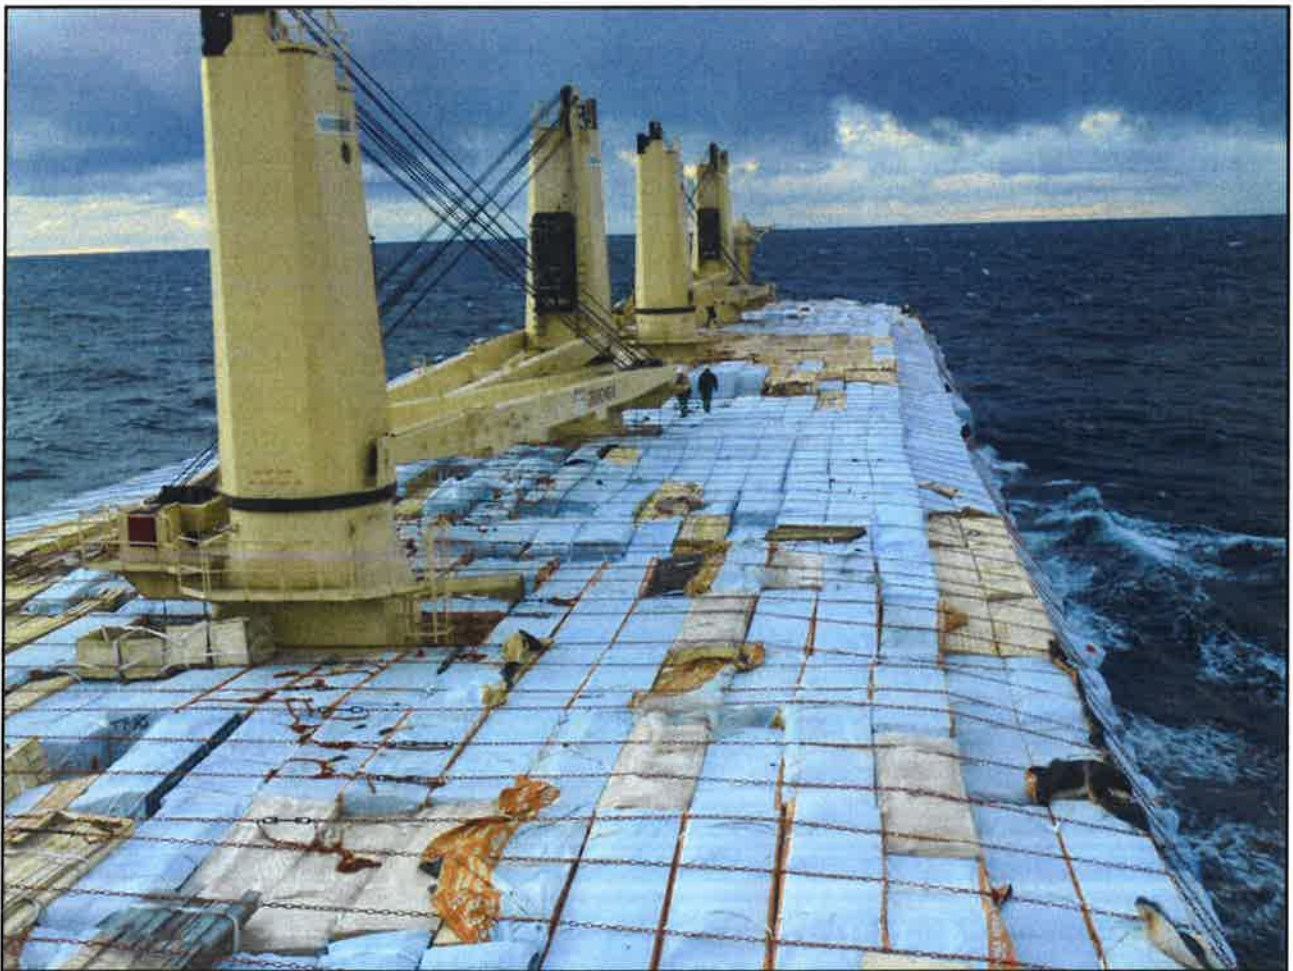
The deck cargo was stacked four packages high on top of the hatch covers and six high on deck. Following the supercargo's instruction, the ship's crew secured the deck cargo by means of top-over lashings<sup>3</sup> using chains and turnbuckles supplied by the charterer (**Figure 2**).

**Figure 2:** *Graig Rotterdam* at sea with timber deck cargo secured by top-over lashings

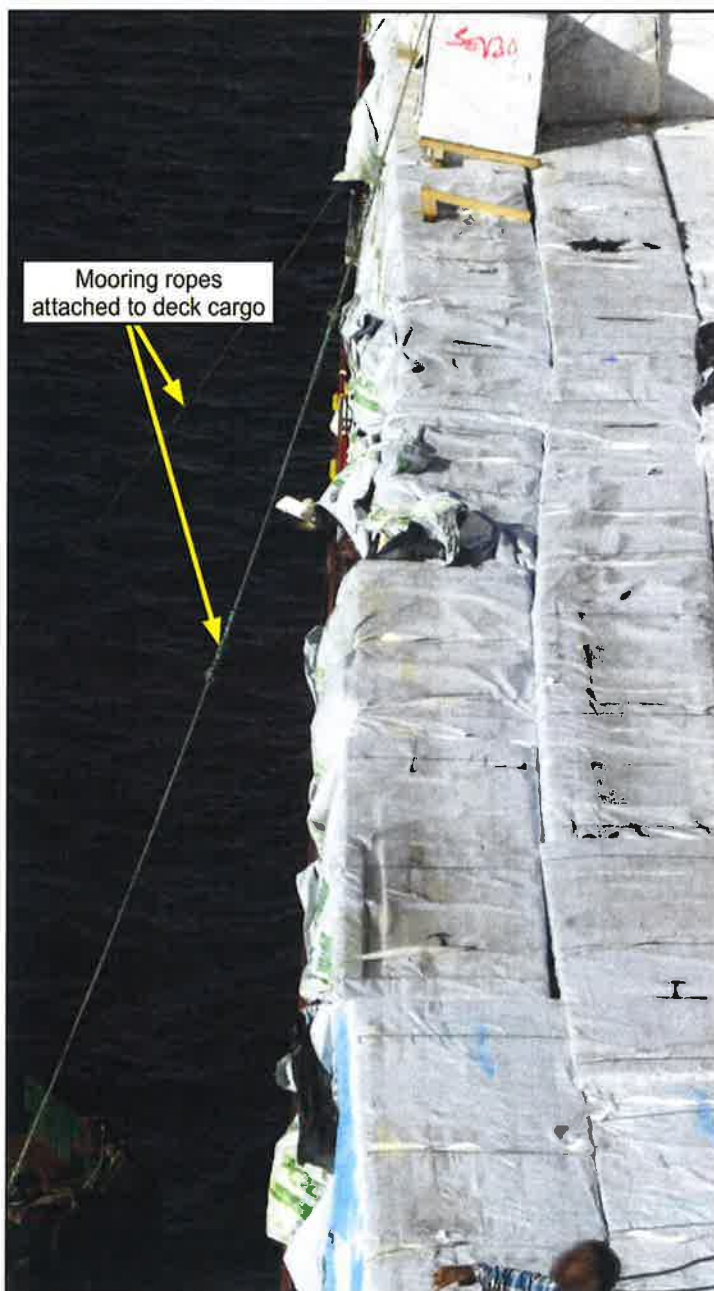
**Figure 3:** Cargo barges secured to deck cargo packages

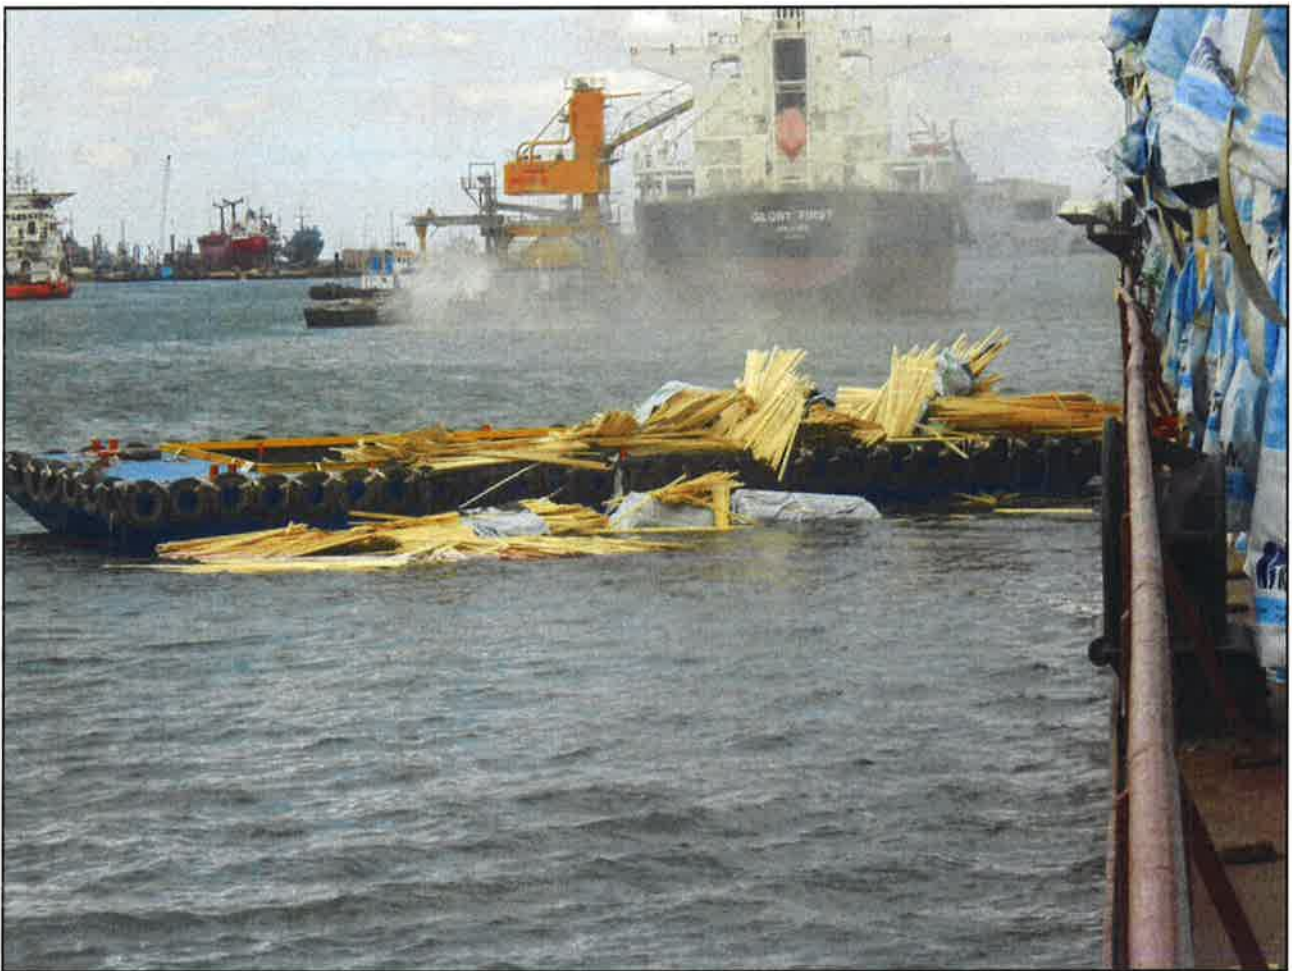
Approximately 20 packages of timber fell from the port side of the stack on top of number 1 hatch cover. Some of the packages fell into the water and the remainder fell into the barge that was secured on *Graig Rotterdam's* port side forward (**Figure 4**).

**Figure 4:** Port side cargo barge, immediately after cargo collapse

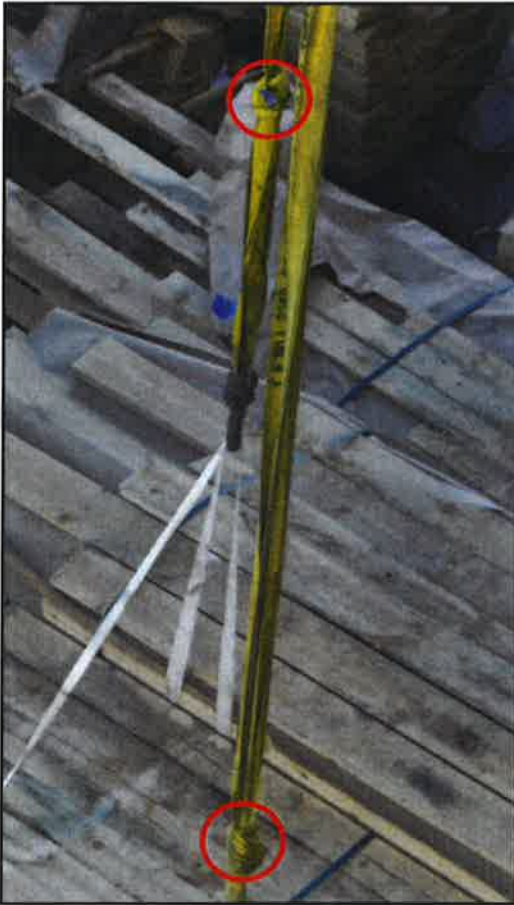
- Knotted cargo slings (**Figure 5**) and open shackles being used as hooks (**Figure 6**) to lift cargo.
- Walking on the edge of deck cargo stacks (**Figure 7**).

**Figure 5: Knotted cargo slings**

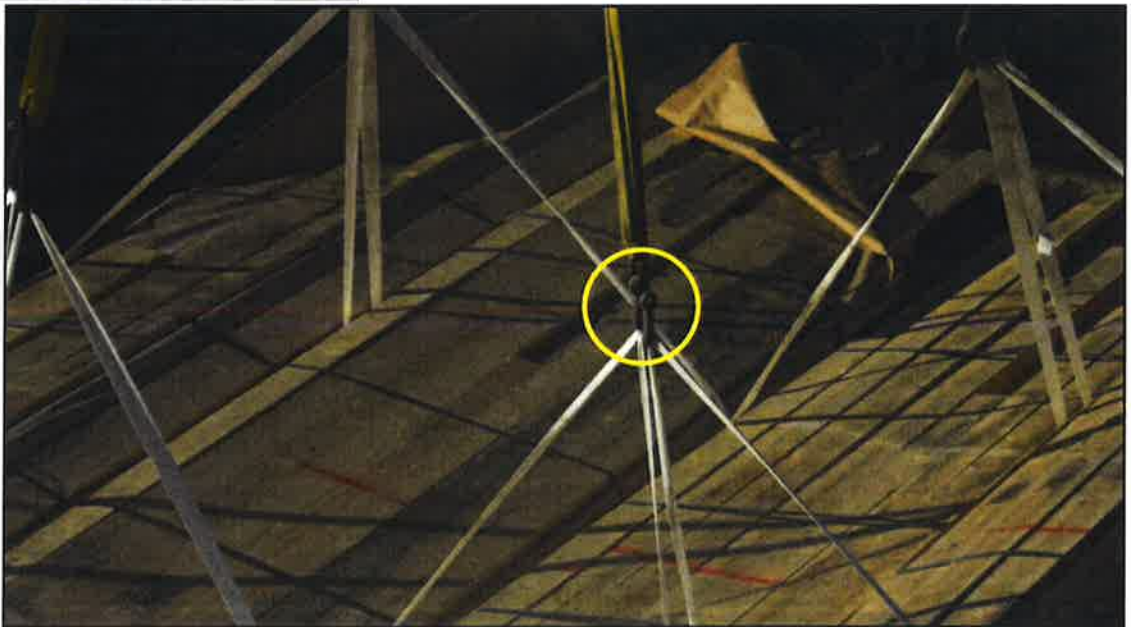
**Figure 6: Open shackles used as cargo hooks**

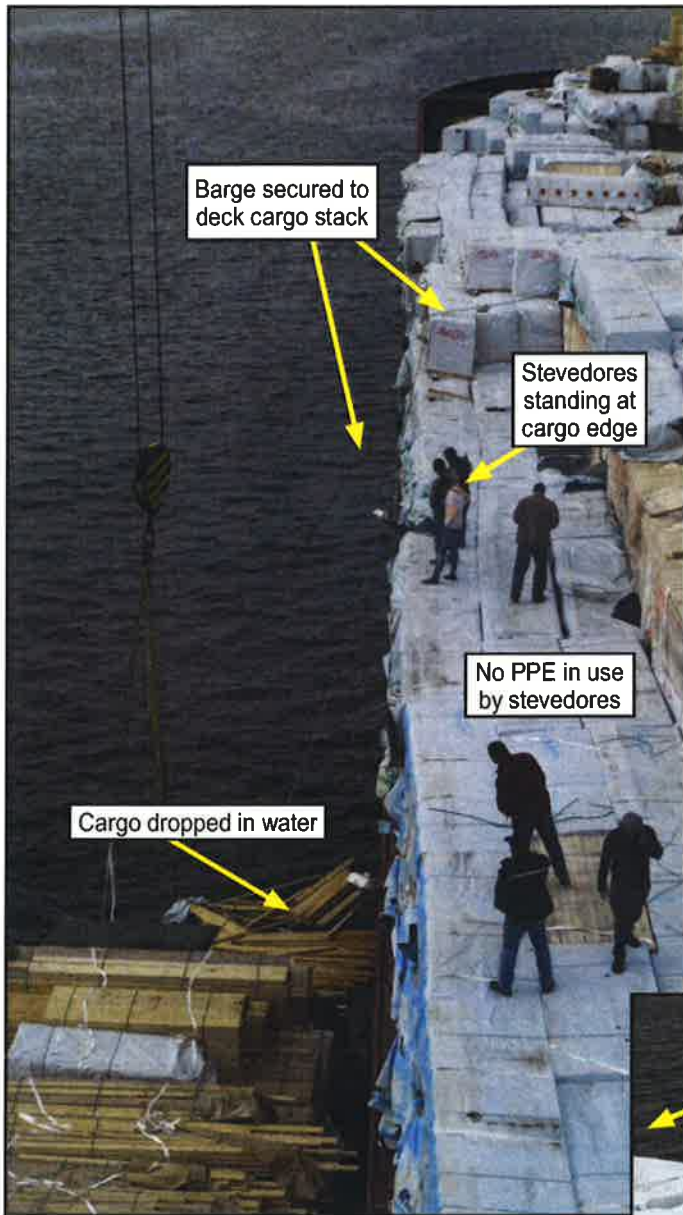
- Personal protective equipment (PPE) not being worn (**Figure 7**).
- Cargo packages being dropped onto the deck or into the water (**Figure 7**).
- Barges being secured to deck cargo stacks (**Figures 7, 8 and 9**).
- Smoking while on the deck cargo stacks.
- Climbing and being lifted by crane from barges to the ship.

**Figure 7: Poor stevedoring practices**

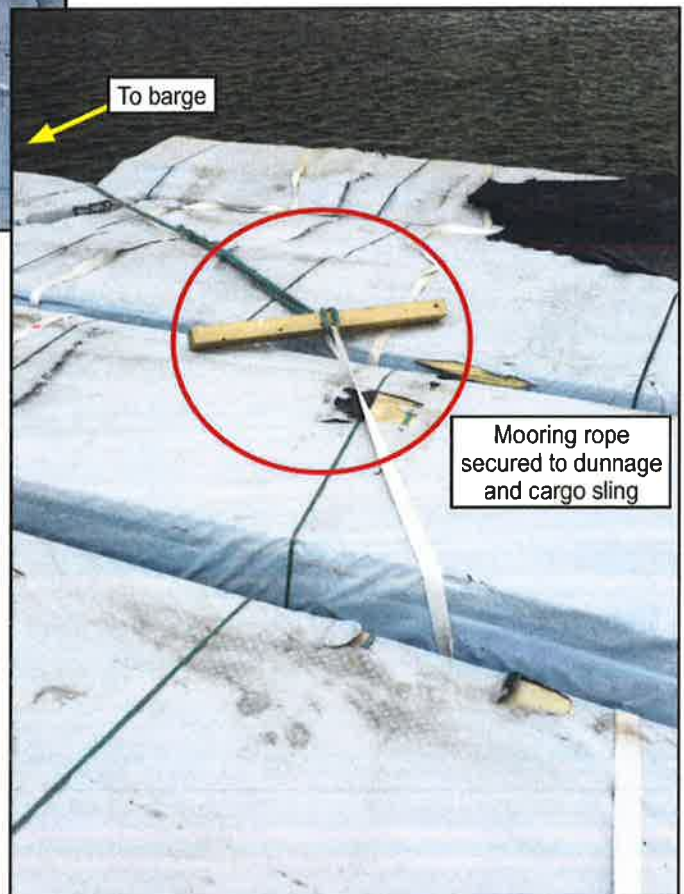
**Figure 8: Barge mooring rope attached to deck cargo stack**

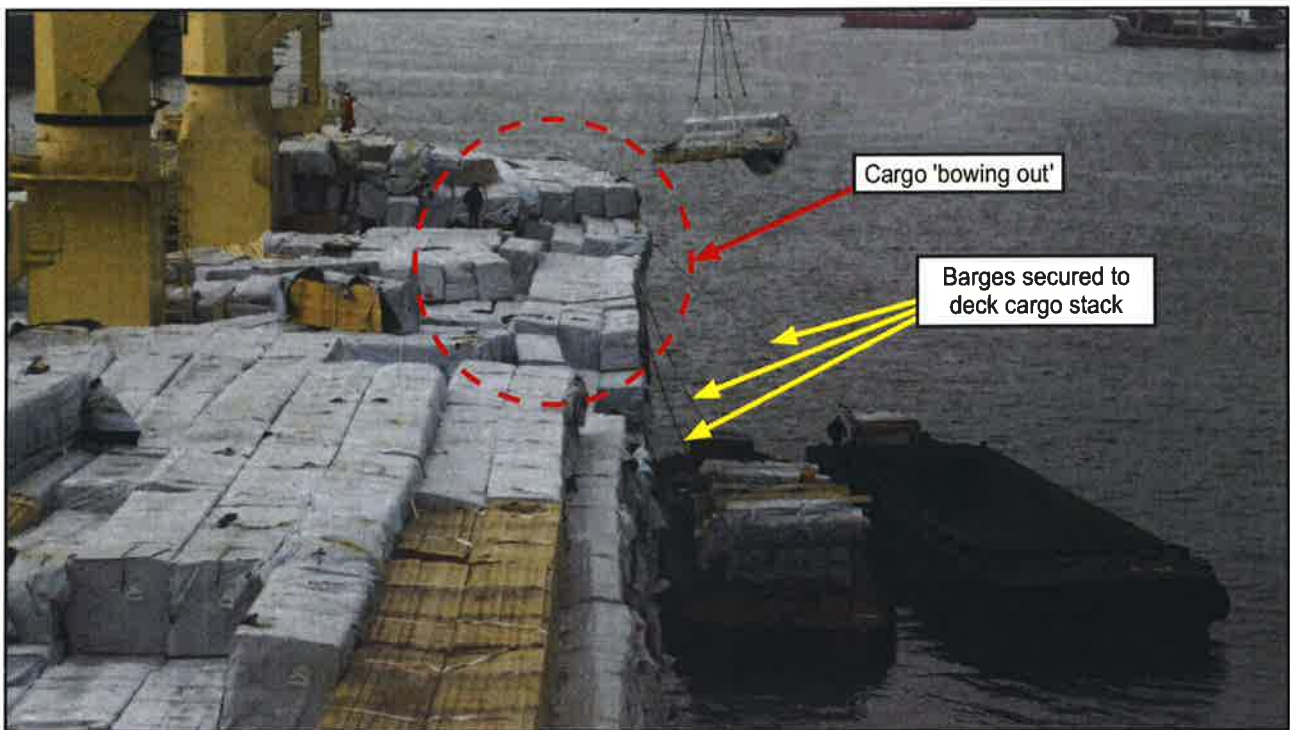
**Figure 9:** Cargo 'bowing out' in fore part of vessel

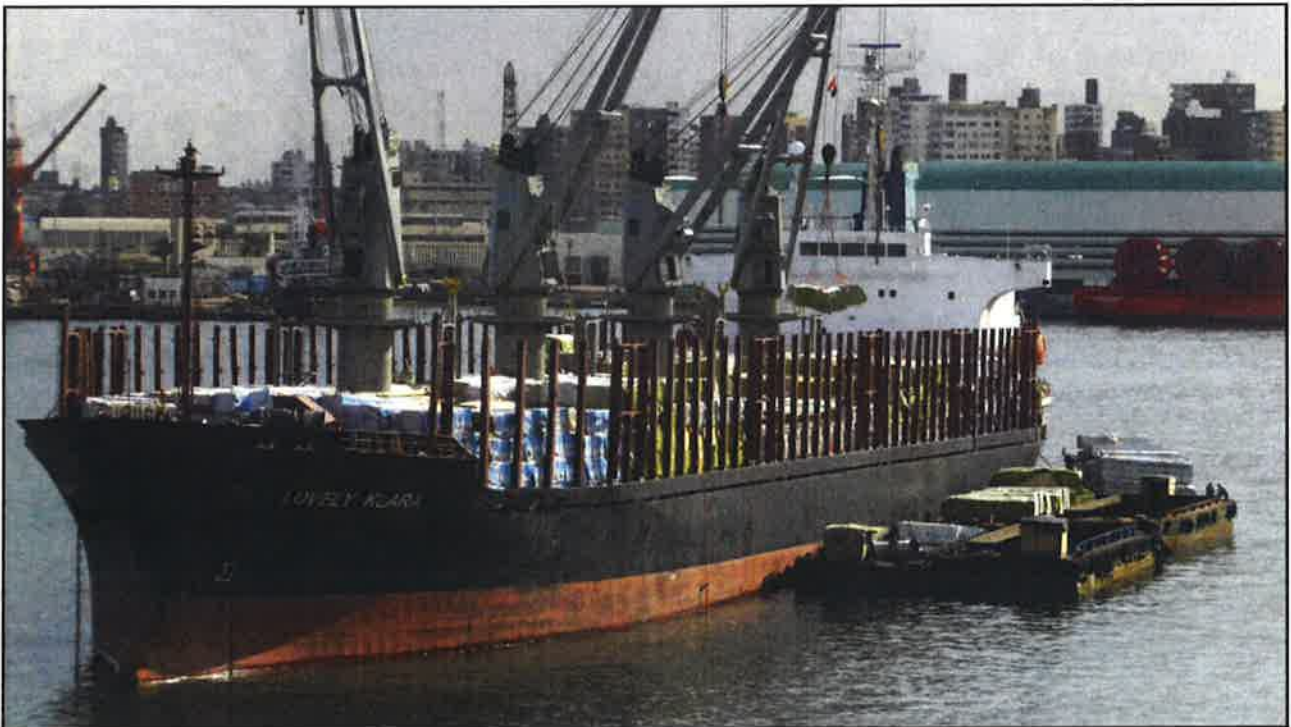
Uprights provide an additional means of securing timber deck cargo packages with limited racking strength for passage, in accordance with the TDC Code. There is no evidence that the cargo packages carried on *Graig Rotterdam* had insufficient racking strength so as to require them to be supported by uprights while on passage. However, provision of uprights would have helped prevent a deck cargo stack from collapsing once the securing lashings had been removed in circumstances such as those faced by *Graig Rotterdam* in Alexandria Port, Egypt. There were two other ships discharging packaged timber cargoes to the same terminal in Alexandria at the time of the accident. Both ships were fitted with steel uprights (Figure 10).

**Figure 10:** A vessel, with steel uprights, discharging a timber deck cargo at the same anchorage
