Konu : Türk Bayraklı Gemilerin Paris MoU Denetim Performans Analizleri

Sirküler No: 104

Konu : Türk Bayraklı Gemilerin Paris MoU
Denetim Performans Analizleri.

Paris Mou Kapsamında Türk Bayraklı Gemilerde Sertifika ve Doküman Bölümü

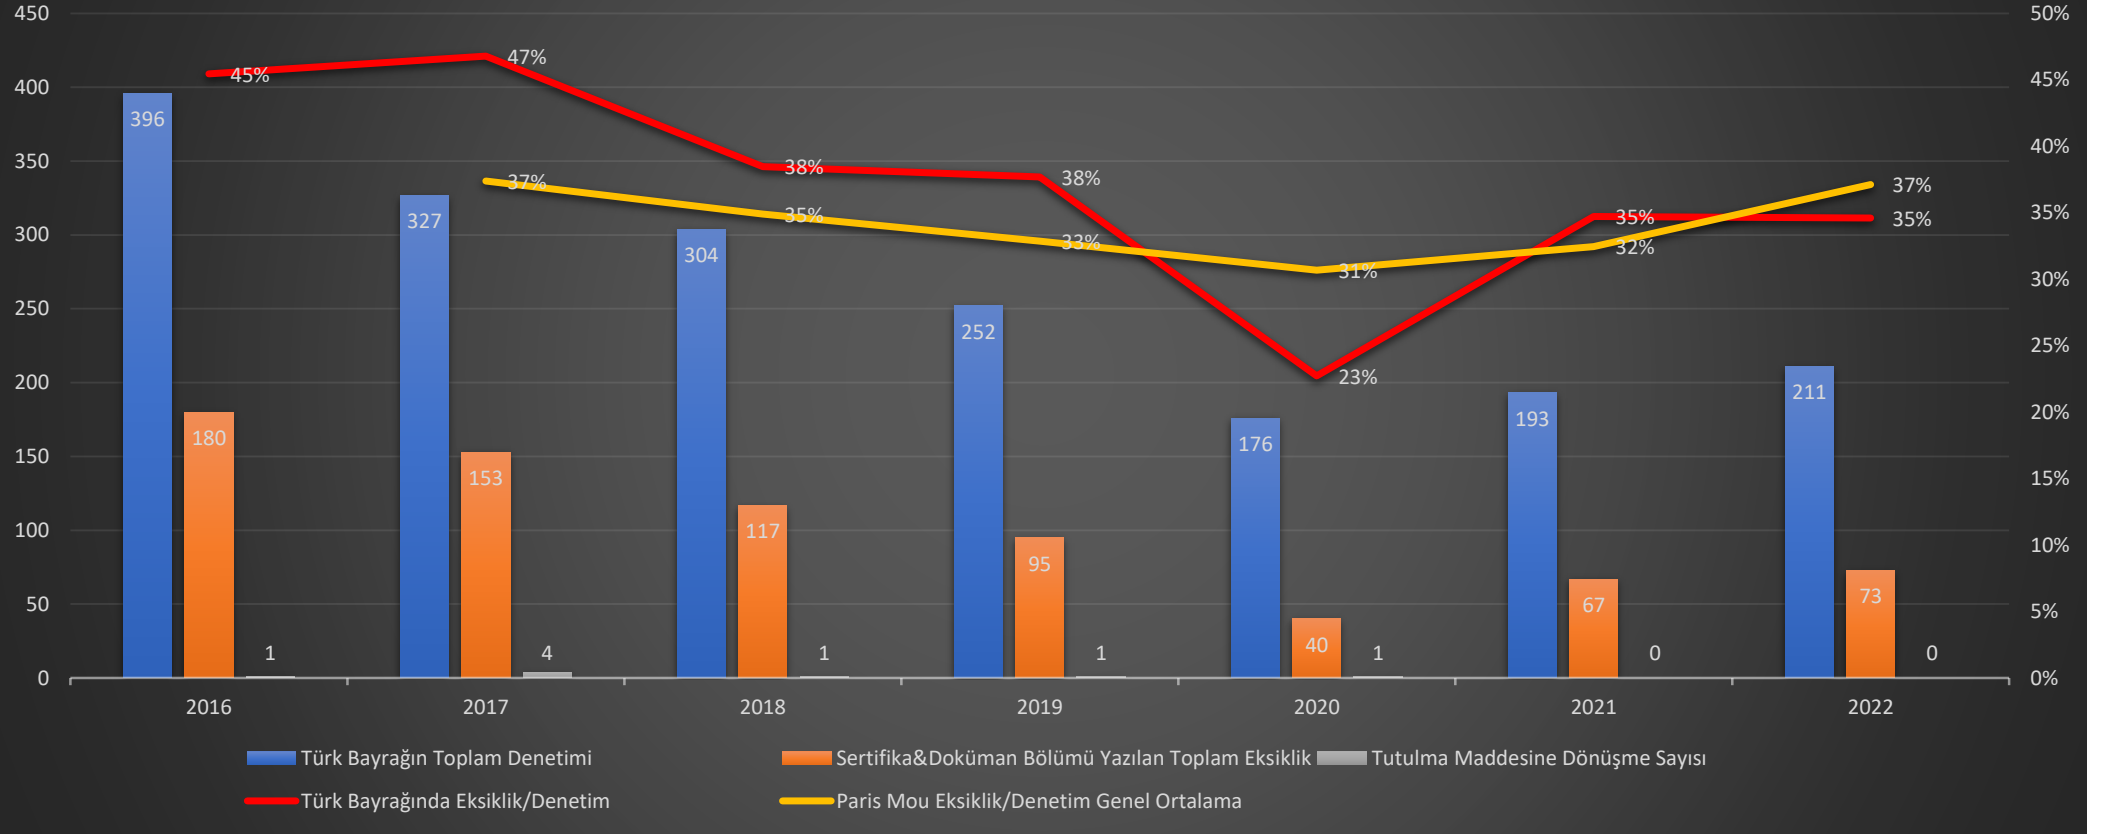
2016-2022 yılları arasında Türk Bayraklı gemilerimizin Paris MoU limanlarında girdiği liman devleti denetimlerinde, gemi sertifikaları ve dökümantasyon alanında gemilerimizde tespit edilen eksiklik sayıları ile Paris MoU'da denetime giren tüm bayrakların genel ortalaması karşılaştırılmıştır.

2020 yılından itibaren Sertifika&Dokümantasyon alanında yazılan eksikliklerde Paris MoU geneline paralel şekilde artış olduğu görülmektedir.

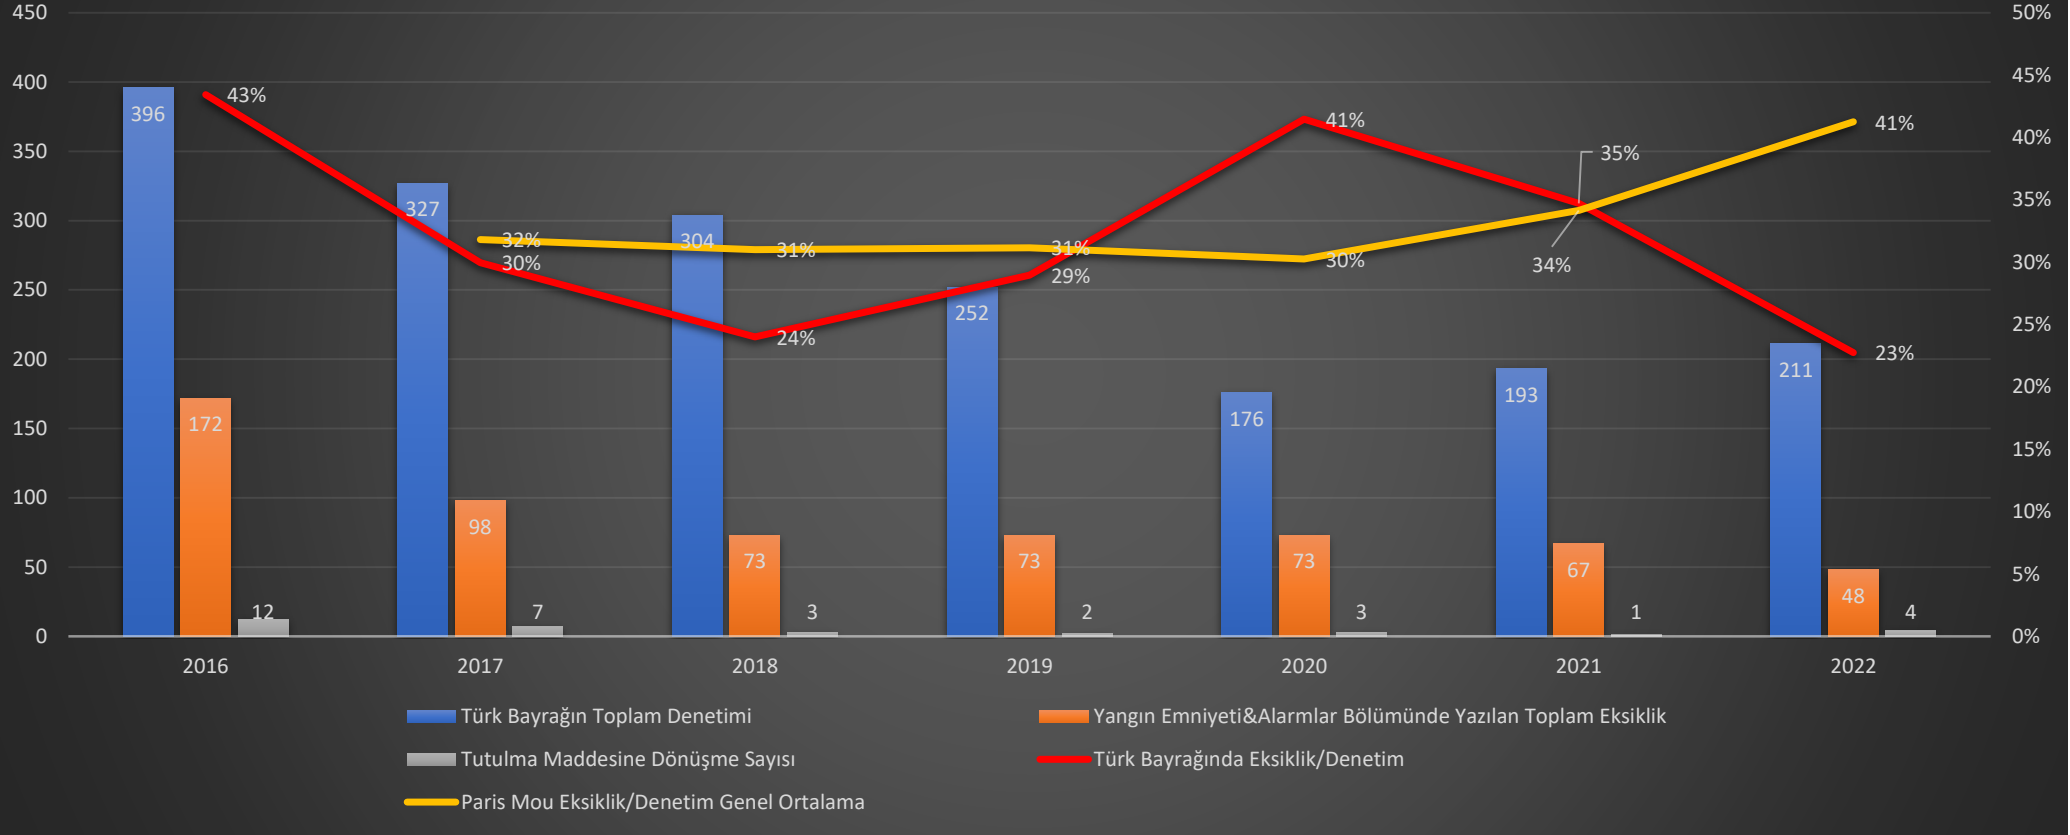
Paris Mou Kapsamında Türk Bayraklı Gemilerde Yangın Emniyeti ve Alarmlar Bölümü

"Yangın Emniyeti ve Alarmlar" alanında denetim başına yazılan eksikliklerin oranı genel olarak azalmış olmakla beraber, bu alanda yazılan eksiklerin tutulma maddesine dönüşme oranı 2022 yılında artmıştır.

2023 yılı için Paris MoU'da ve diğer memorandumlarda "Yangın Emniyeti" alanında yoğunlaştırılmış denetim kampanyası (CIC) düzenlenecek olup, gemilerin bu alanda hazırlıklı olmaları amacı ile söz konusu CIC, 1 Haziran 2023 tarihinden itibaren bayrak devleti denetimlerinde de (önsörvey) uygulanacaktır.

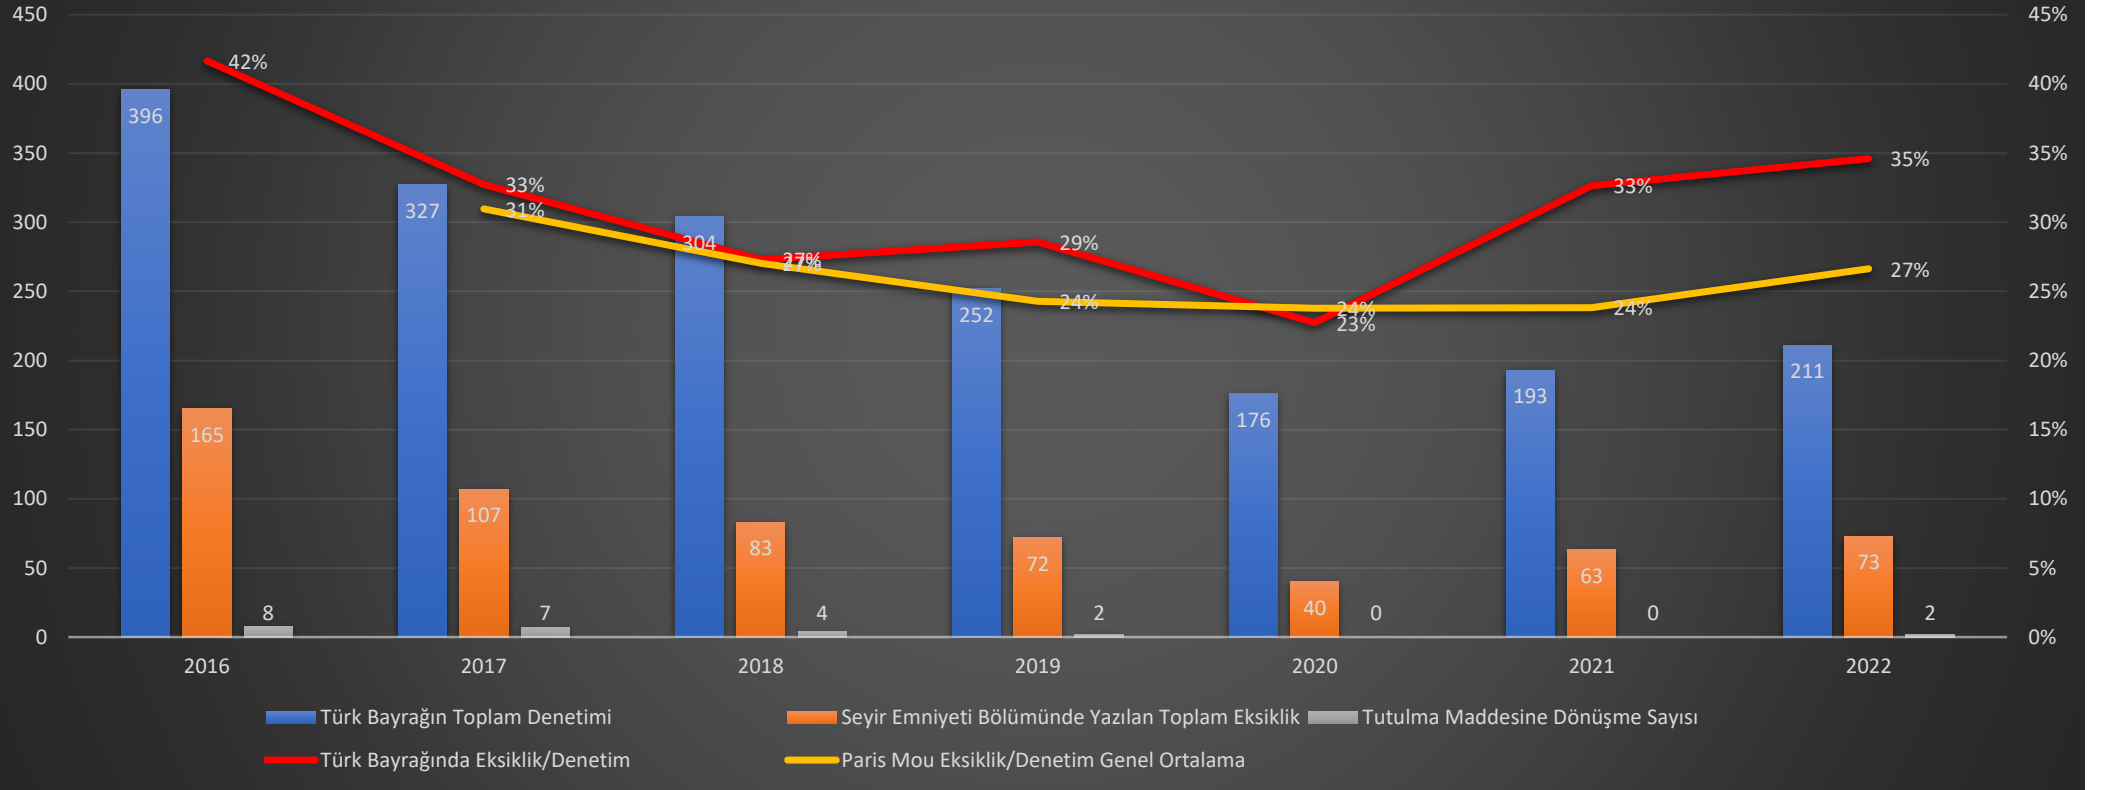
Paris Mou Kapsamında Türk Bayraklı Gemilerde Seyir Emniyeti Bölümü

"Seyir Emniyeti" alanında 2016-2020 yılları arasında denetimlerde bu alanda eksiklik yazılma oranı genel olarak düşerken; 2020 sonrası ise bu alandaki eksiklik yazılma oranı tekrar yükselmiştir.

Harita ve seyir neşriyatlarının güncelliği, pusula hatası, sefer planı vb. eksiklikler, bu alanda yazılan genel eksikler olup önlem alınması gerekmektedir.

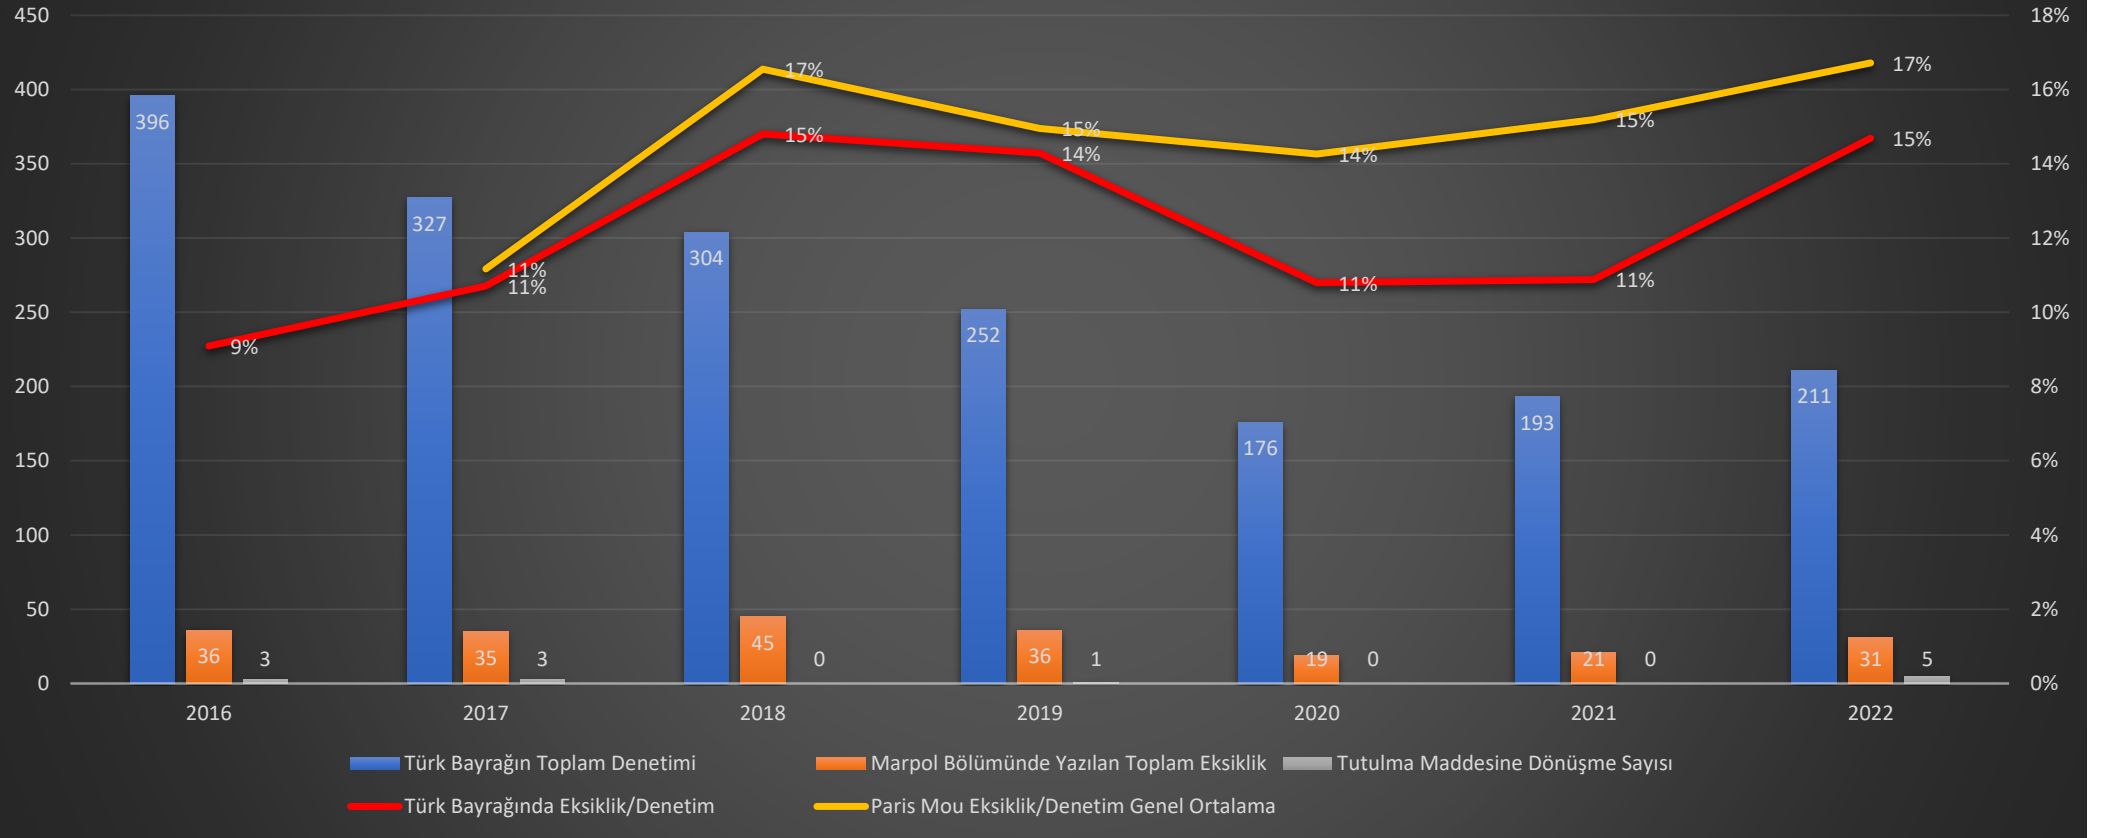
Paris Mou Kapsamında Türk Bayraklı Gemilerde Marpol Bölümü

Türk bayraklı gemilerimizde Marpol alanında tespit edilen eksiklik sayıları, Paris MoU genel ortalamasına paralel şekilde artmıştır.

Eksikliklerin tutulma maddesine dönüşme oranı ise 2022 yılında en yüksek seviyeye ulaşmıştır. Söz konusu alanda gerekli önlemlerin alınması önem arz etmektedir.

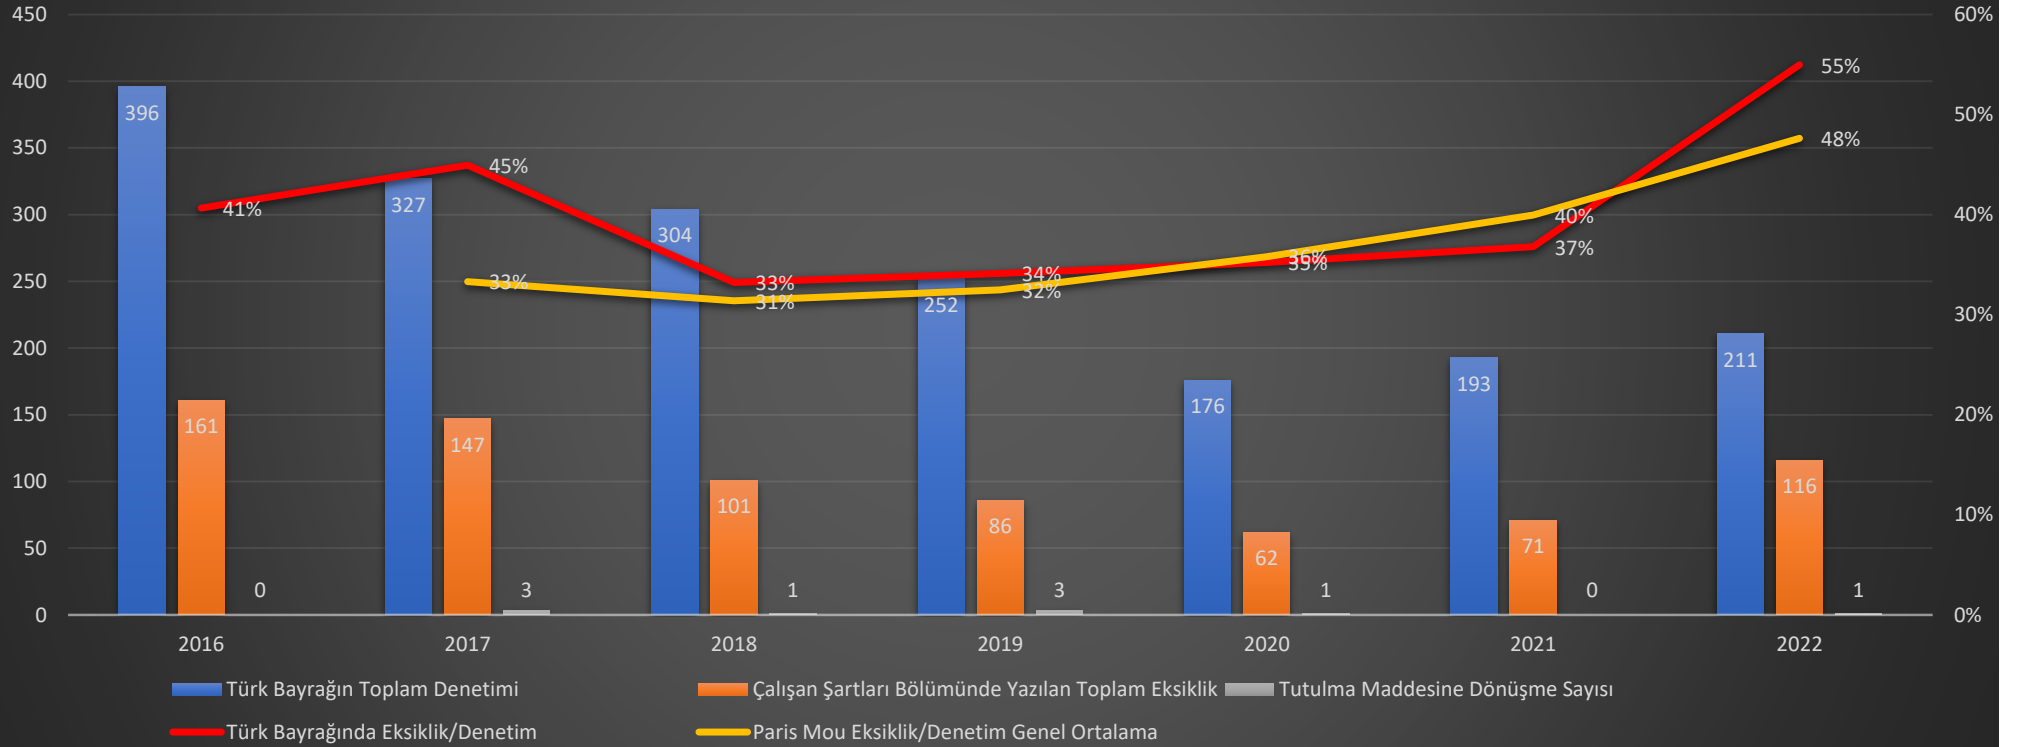
Paris Mou Kapsamında Türk Bayraklı Gemilerde Labour Condition

2016-2022 arası periyotta Türk bayraklı gemilerde "Çalışma Şartları" konusunda tespit edilen eksiklik sayıları Paris MoU genel ortalamasının üzerinde artmıştır.

Paris MoU'da bu alanda denetime giren tüm gemilere yazılan eksiklik ortalamasının yükselmesi de Paris MoU liman devleti denetçilerinin bu alana giderek daha fazla önem verdiği yönünde yorumlanmaktadır. Bu kapsamda, maaş ödemelerinin uluslararası standartlara uygun ve düzenli şekilde yapılması hususu önem arz etmekte olup, MLC konusunda gemi personeline ayrıca eğitim verilmesi vb. önlemlerin alınması gerekmektedir.

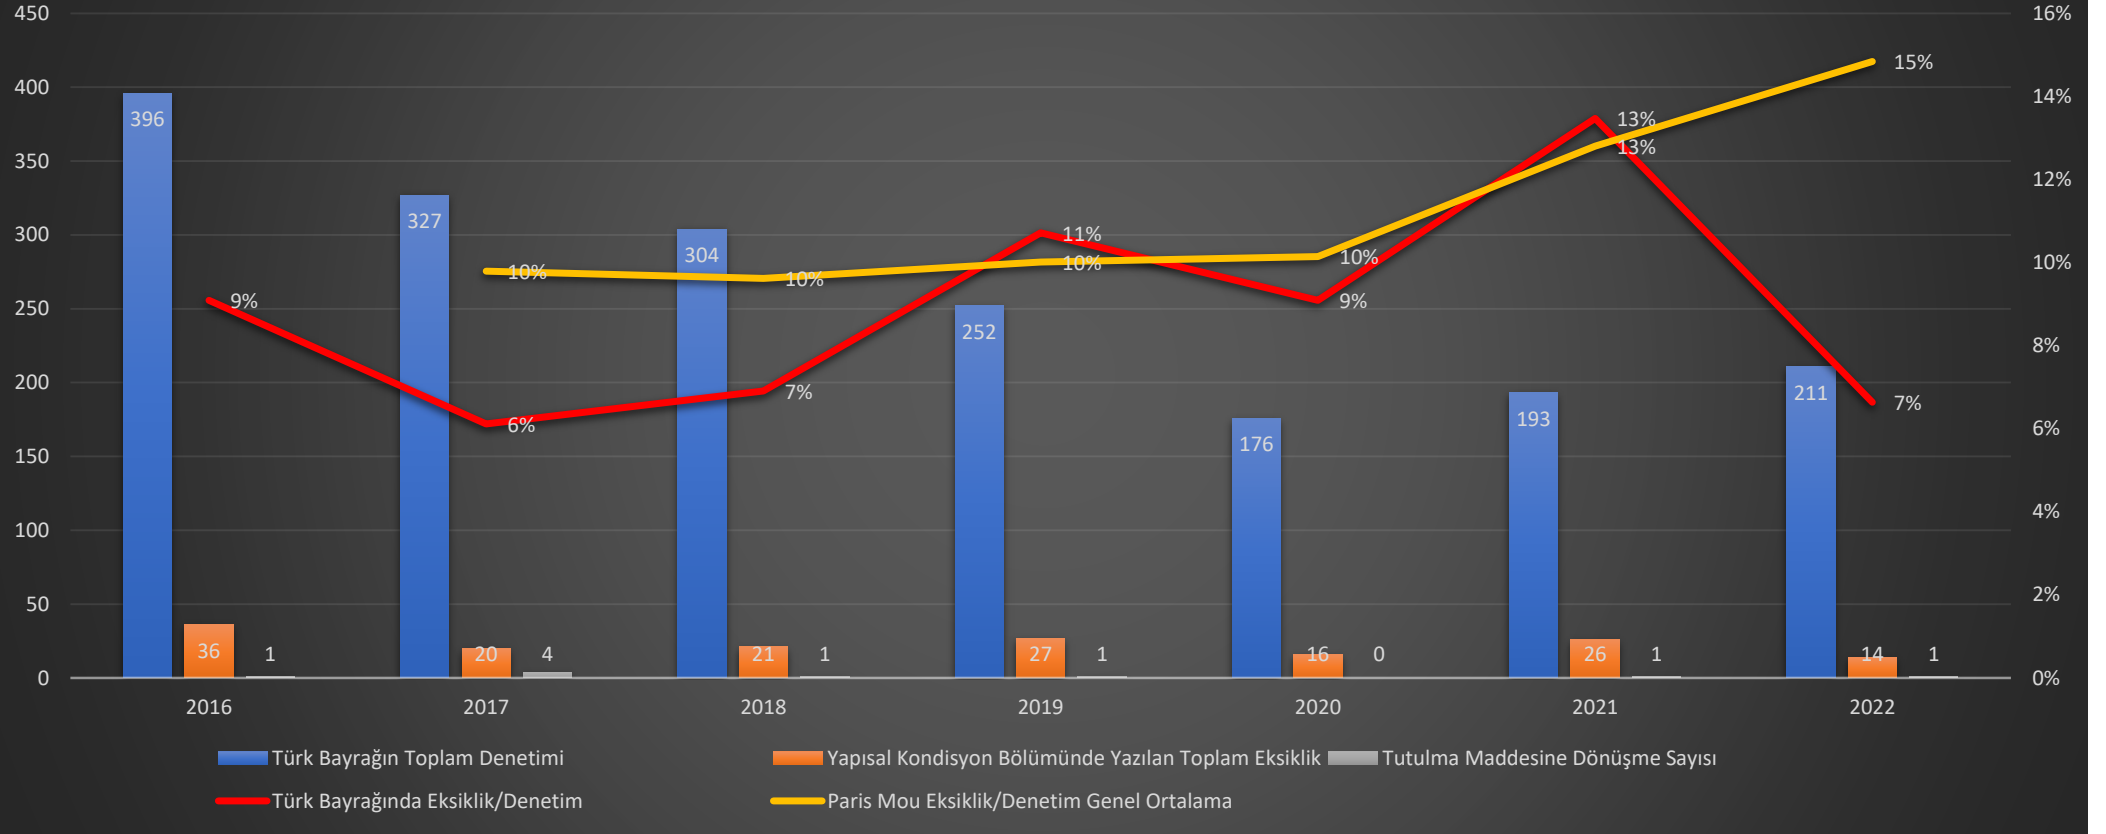
Paris Mou Kapsamında Türk Bayraklı Gemilerde Yapısal Kondisyon Bölümü

"Yapısal Kondisyon" alanında Türk bayrak gemilerimize eksiklik yazılma oranının Paris MoU ortalamasının genel olarak altında kaldığı görülmektedir.

Türk bayrak filosunun yaş ortalaması yüksek olmasına rağmen, bu alanda Paris MoU ortalamasının genel olarak altında kalması da bakım ve tutumun iyi yapıldığı şeklinde değerlendirilmektedir.

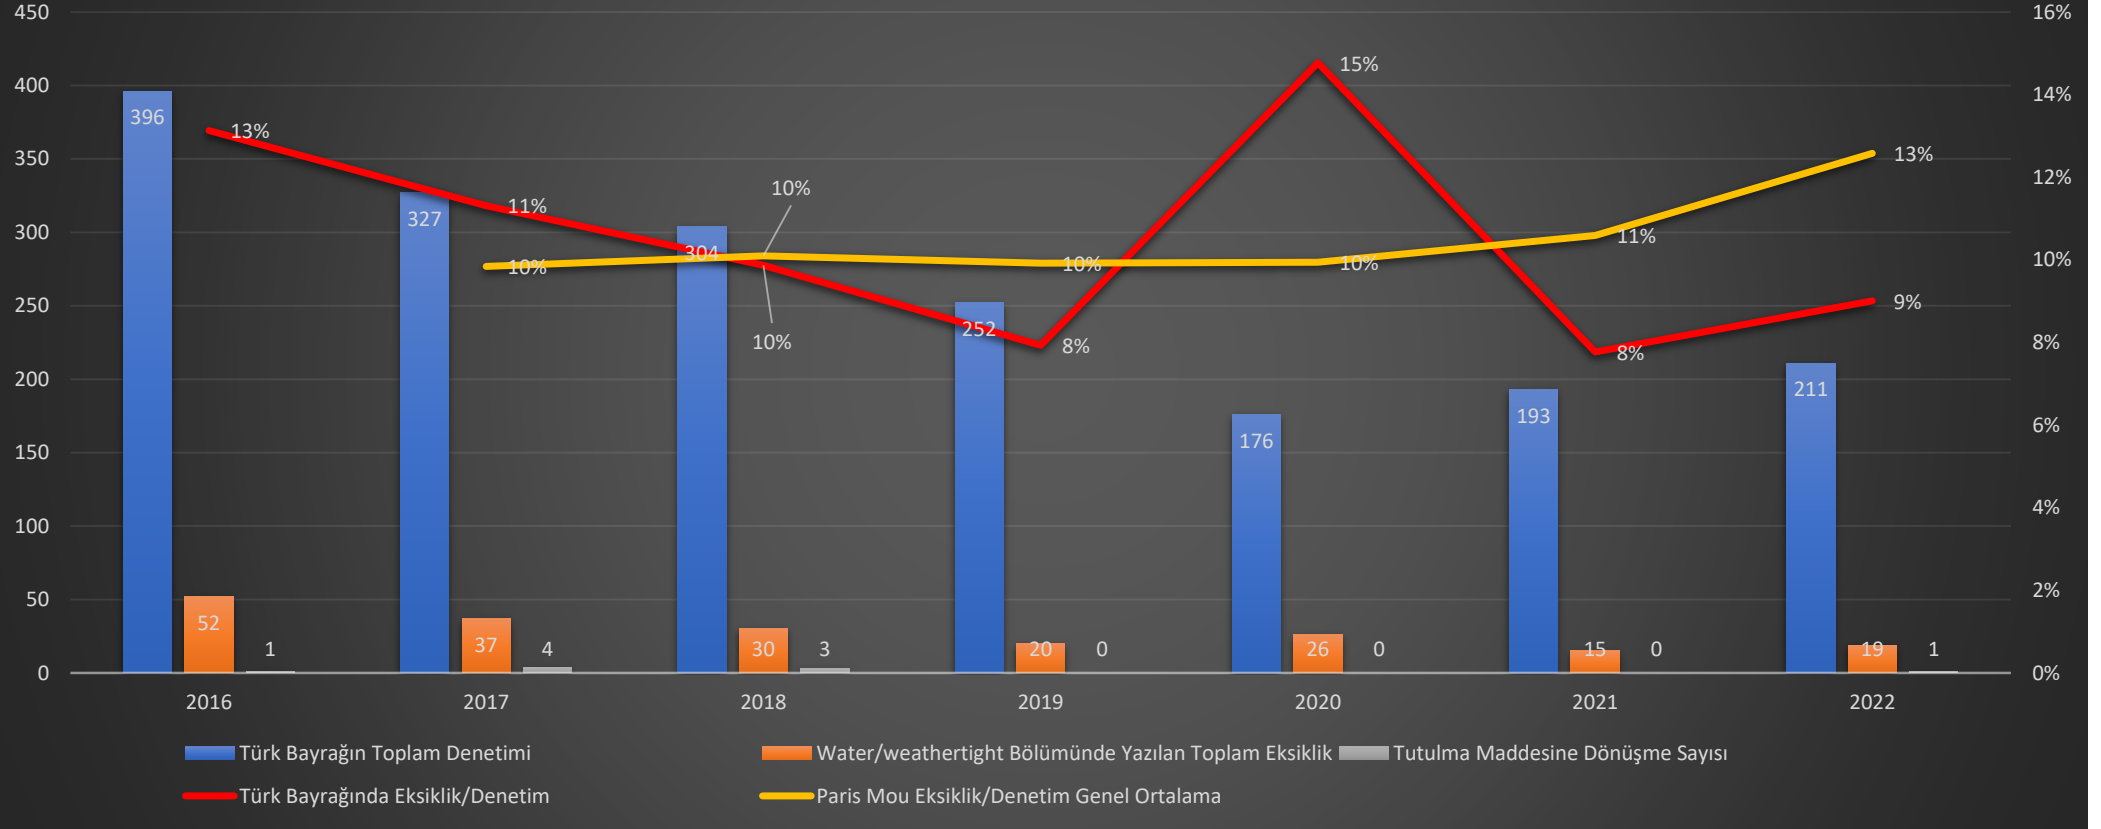
Paris Mou Kapsamında Türk Bayraklı Gemilerde water/weathertight Kondisyonu

Gemilerimizin "water/weathertight" alanında genel olarak Paris MoU ortalamasının altında kalması da bakım ve tutum konusunda Türk gemiadamlarımızın başarısı olarak değerlendirilmektedir.

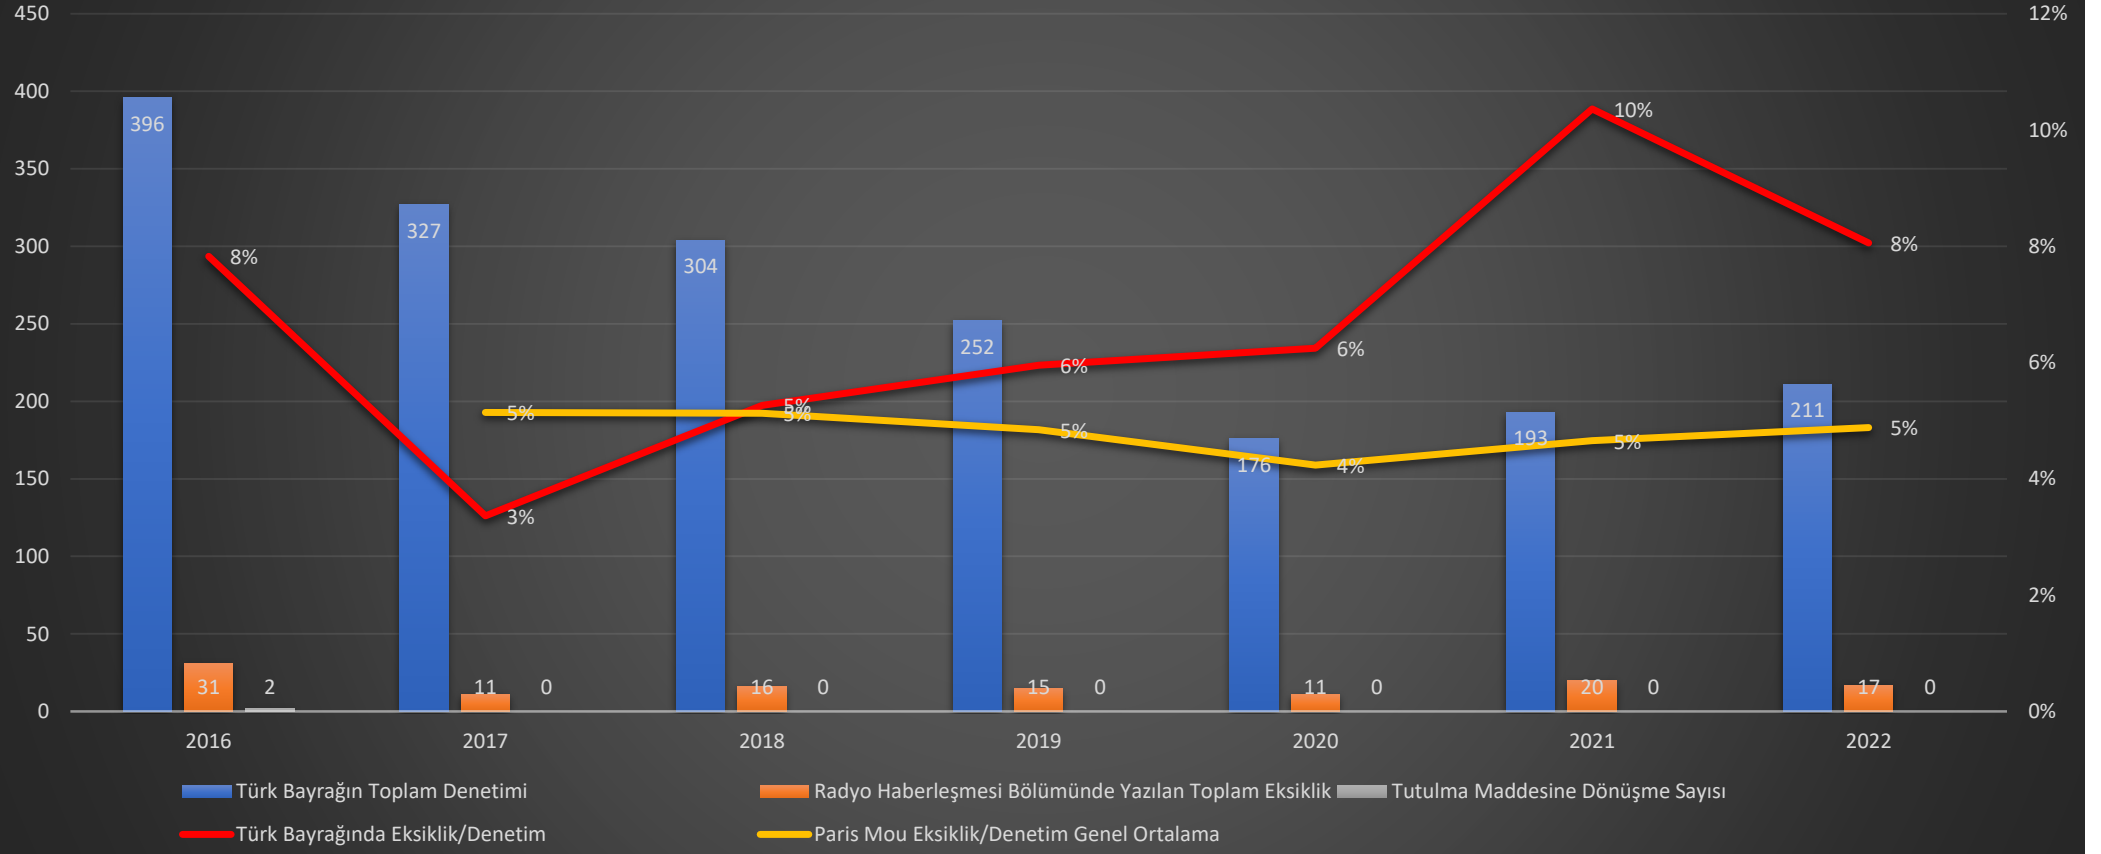
Paris Mou Türk Bayraklı Gemilerde Radyo Haberleşmesi

Radyo Haberleşmesi alanında 2017 yılı haricinde Paris MoU ortalamasının altına inilememiştir.

Özellikle cihaz testleri, testlerin uygun şekilde kayıt edilmesi konusunda zabitanın bilgilendirilmesi önem arz etmektedir.

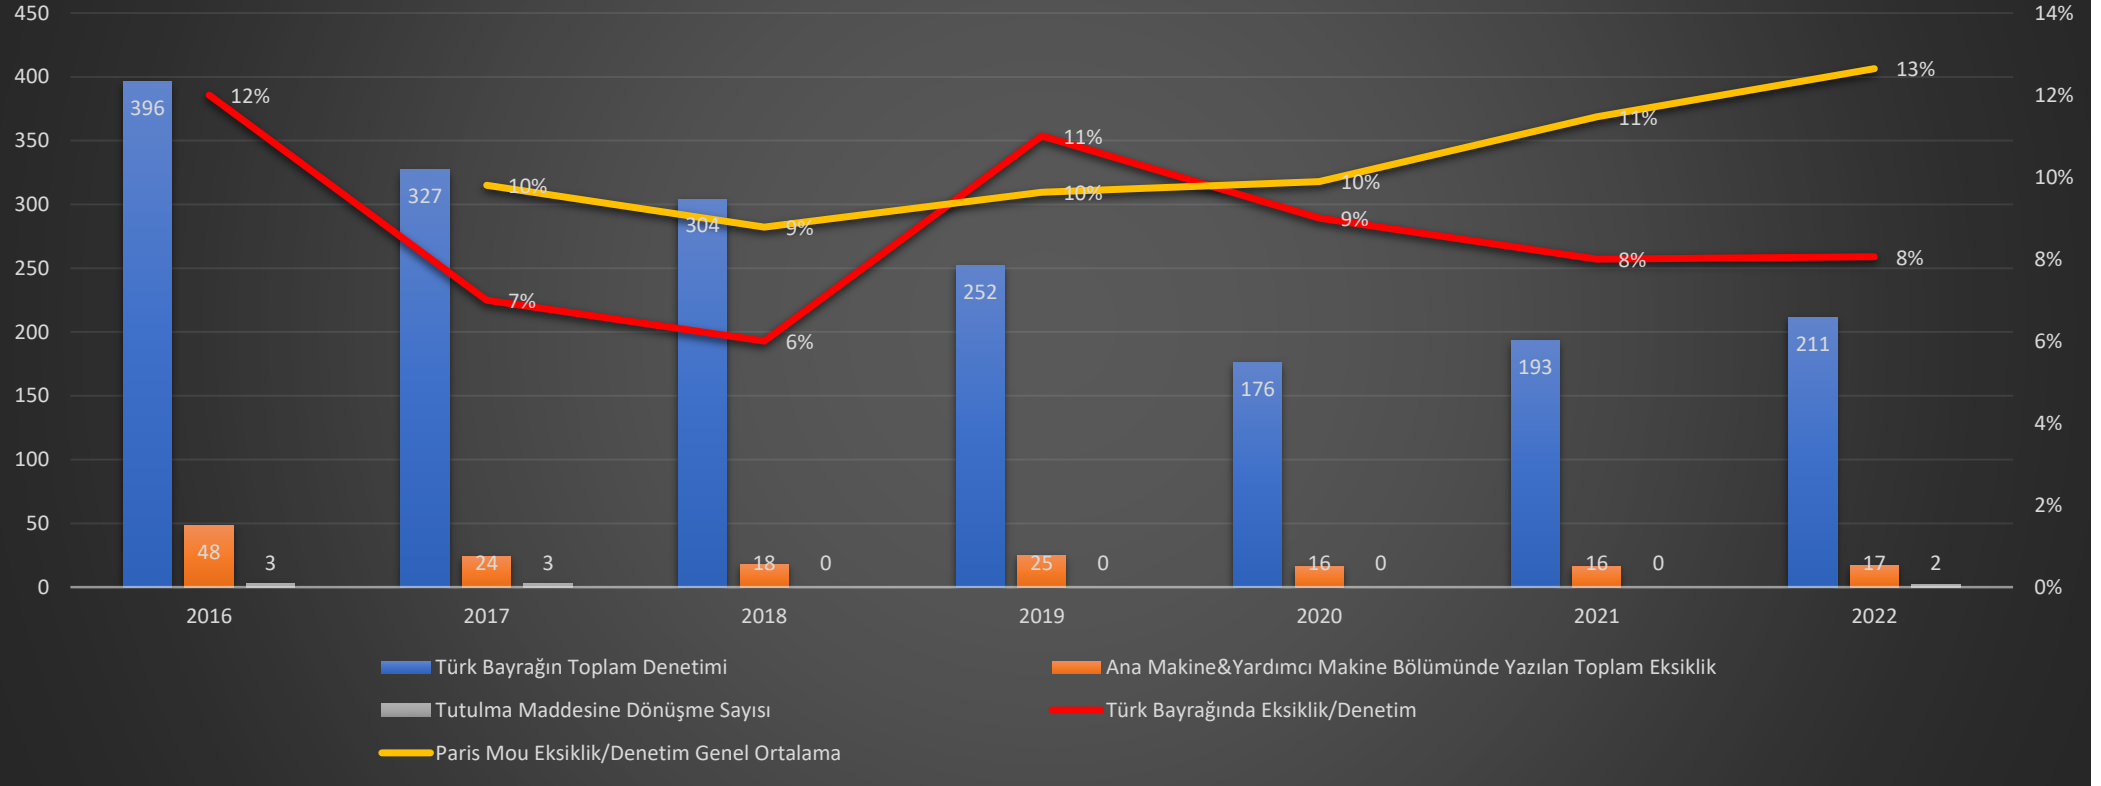
Paris Mou Kapsamında Türk Bayraklı Gemilerde Ana Makine ve Yardımcı Makine Bölümü

Türk bayraklı gemiler "Ana Makine ve Yardımcı Makine" alanında genel olarak Paris MoU ortalamasının altında olmakla beraber, 2022 yılında yazılan eksikliklerin tutulmaya dönüşme oranı tekrar 2016-2017 seviyelerine tekrar yükselmiştir.

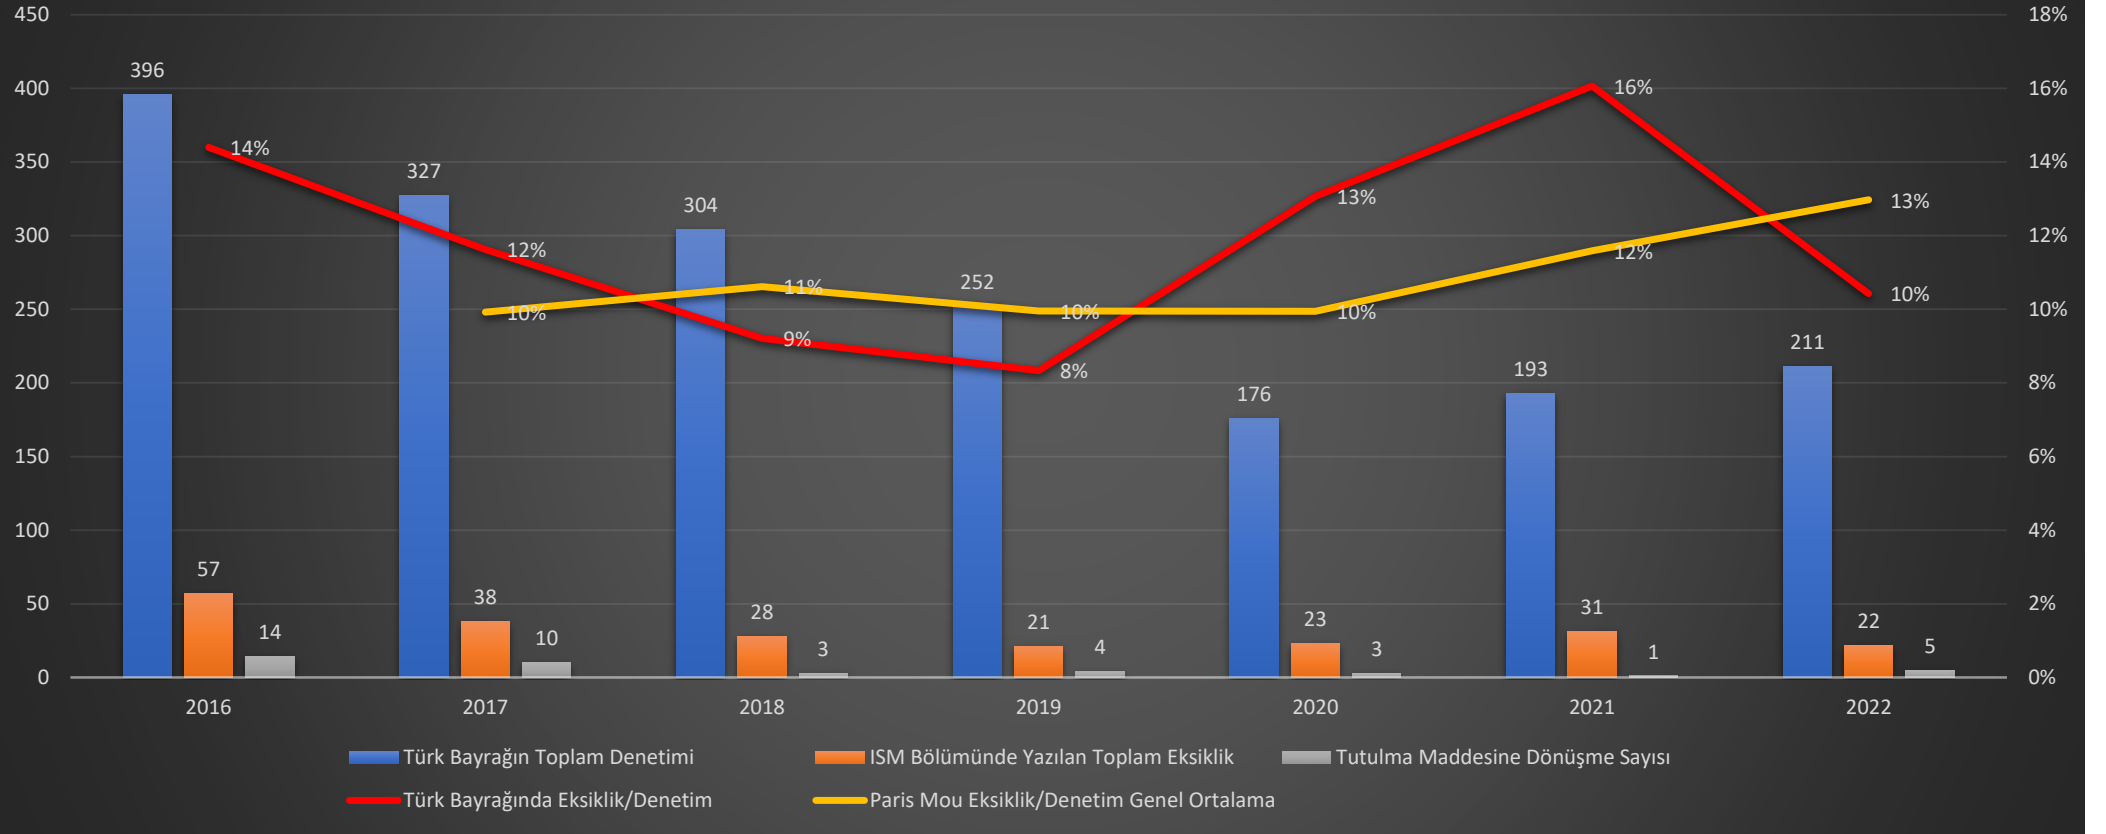
Paris Mou Kapsamında Türk Bayraklı Gemilerde ISM

Yazılan eksikliğin tutulma maddesine dönüşme oranı en yüksek olan alanlardan biri olan ISM eksiklerinde, eksiklerin tutulma maddesine dönüşme oranı son 5 yılın en yüksek oranına yükselmiştir.

İnsan faktörünün ağırlıkta olduğu bu eksikliklerde, gemi personelinin gemiye, gemi ekipmanlarına ve acil durum operasyonlarına aşina olmasını sağlamak üzere eğitimlere azami önem verilmelidir.

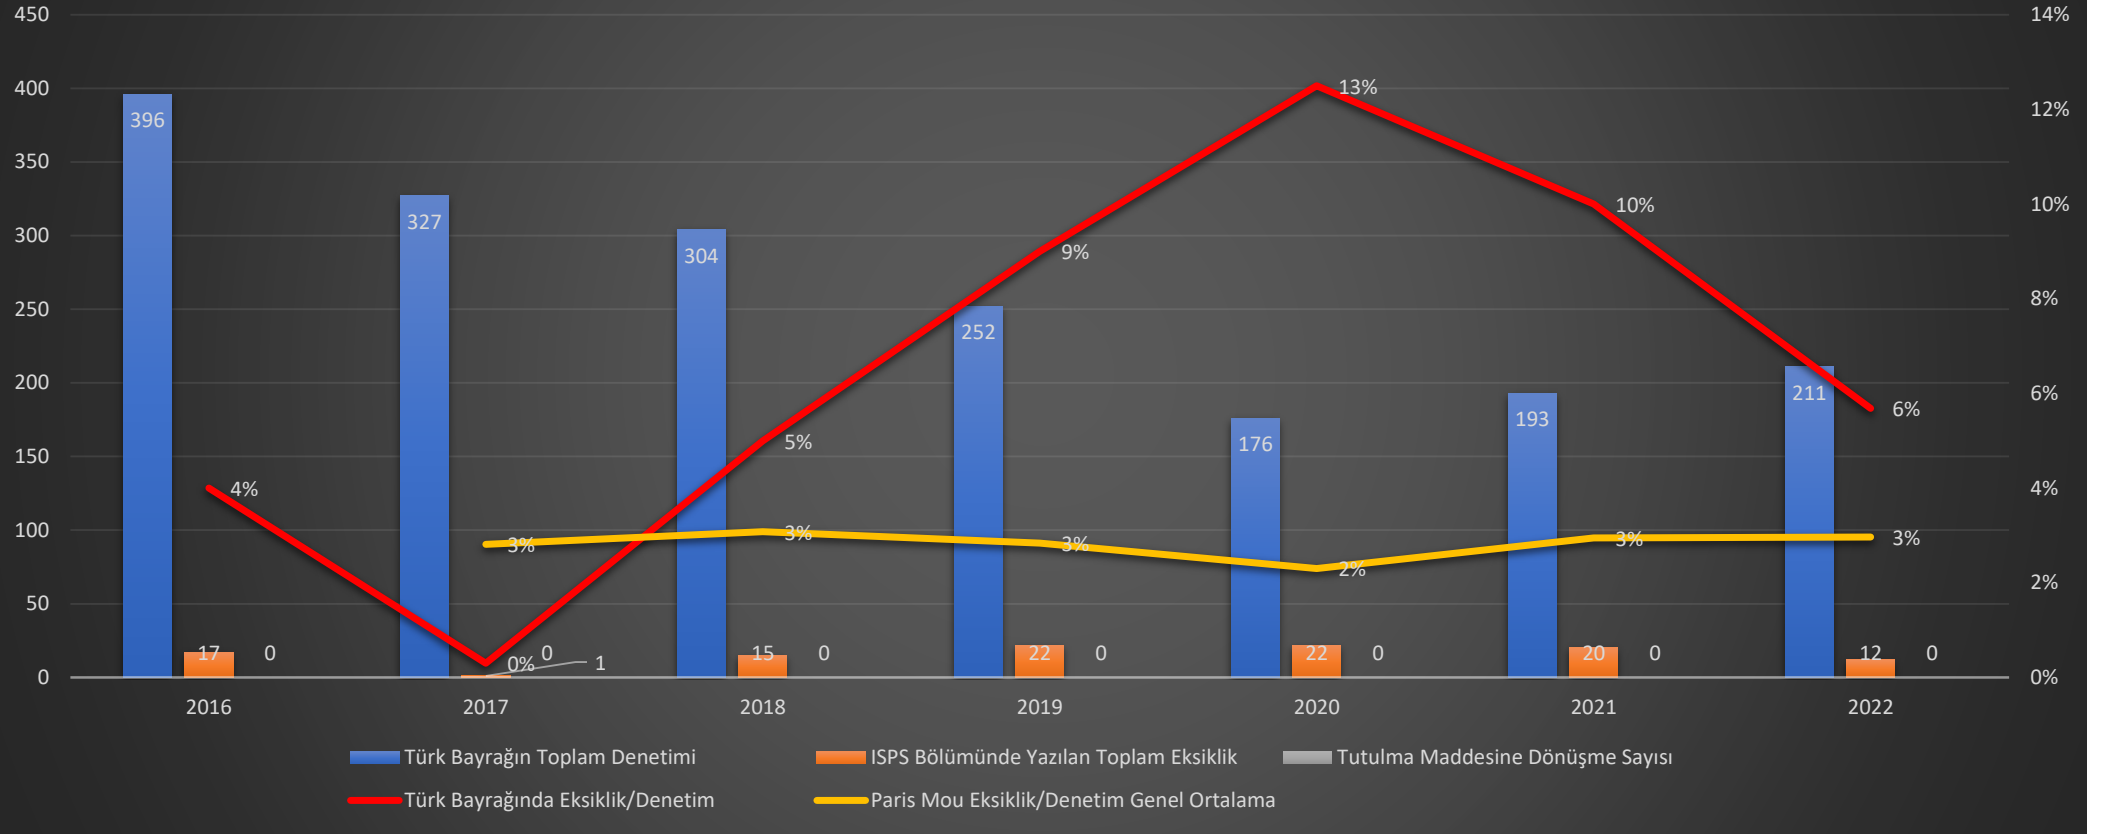
Paris Mou Kapsamında Türk Bayraklı Gemilerde ISPS

2020 yılında gemilerimize ISPS alanında eksiklik yazılma oranı %13 gibi yüksek bir orana çıkmıştır.

2022 yılı itibarıyla hala Paris MoU'nun bu alandaki oranının üzerindedir.

Özellikle gemiye giriş kontrolleri, PSCO'dan kimlik talep edilerek visitor log book'a kaydedilmesi vb. hususlar hala ana eksiklik olarak yazılmakta olup, önlem alınması gerekmektedir.

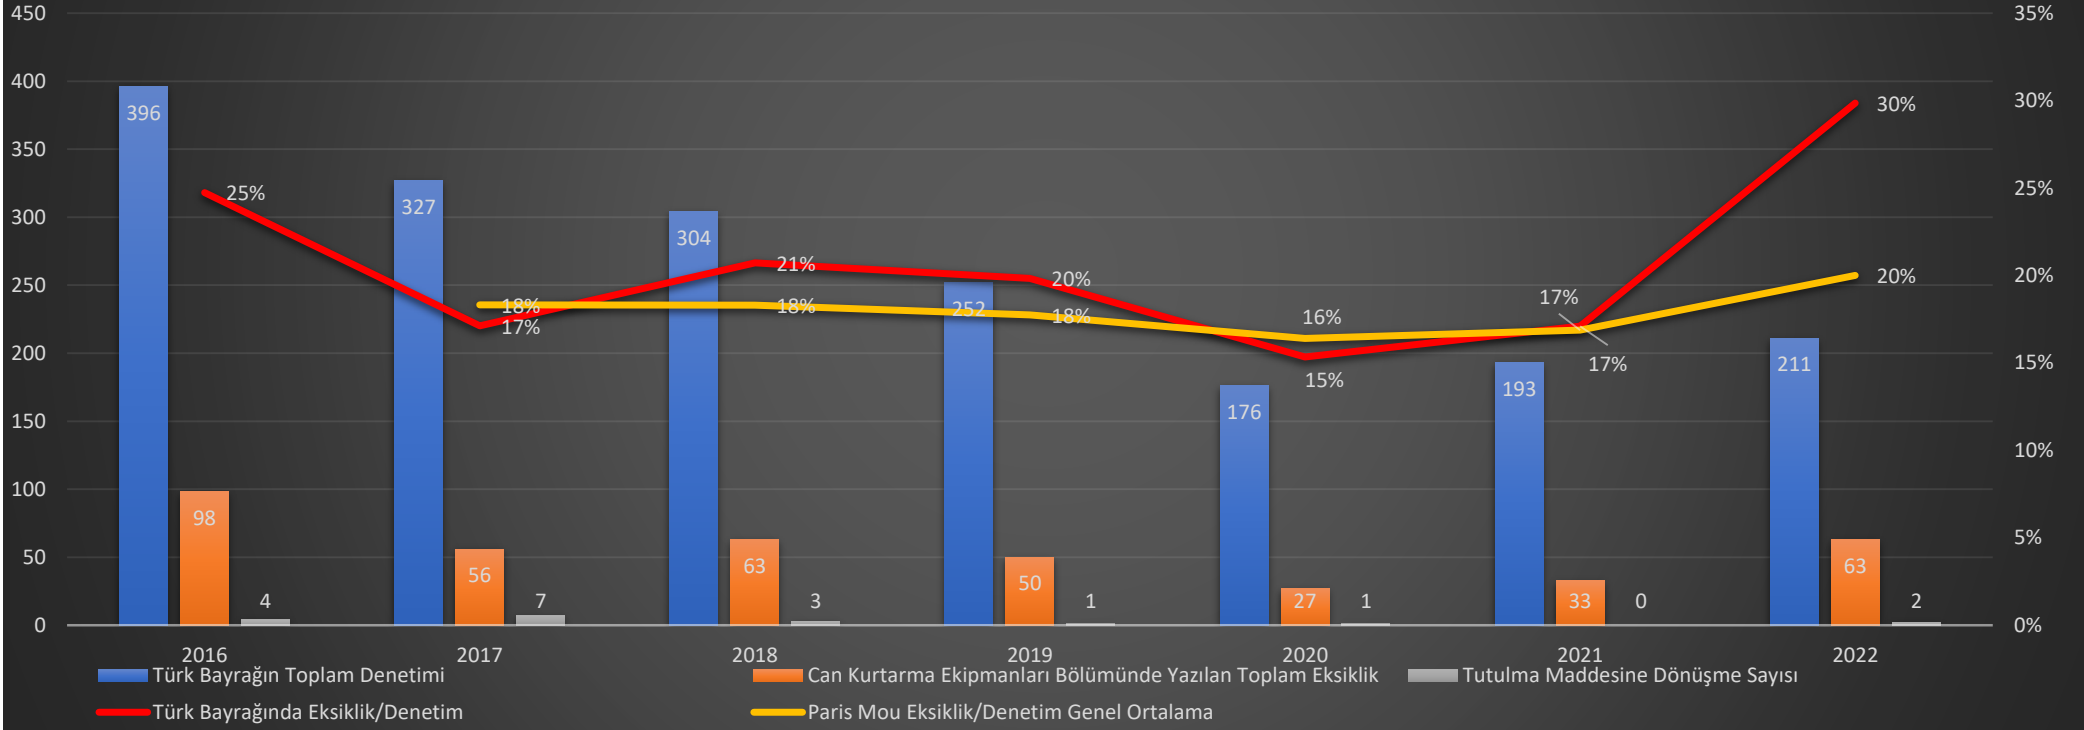
Paris MoU Kapsamında Türk Bayraklı Gemilerde Can Kurtarma Ekipmanları Bölümü

2016 yılından 2021 sonuna kadar Paris MoU ortalaması ile paralel giden eksiklik/denetim oranında 2022 itibarıyla Paris MoU ortalamasının gerisine düşülmüştür.

Tespit edilen eksiklerin tutulma maddesi olarak değerlendirilmesi nedeniyle önlem alınması gerekmektedir.
