Konu : Türk Bayraklı Gemilerin Paris MoU Denetim Performans Analizleri

Sirküler No: 104

Konu : Türk Bayraklı Gemilerin Paris MoU
Denetim Performans Analizleri.

Paris Mou Kapsamında Türk Bayraklı Gemilerde Sertifika ve Doküman Bölümü

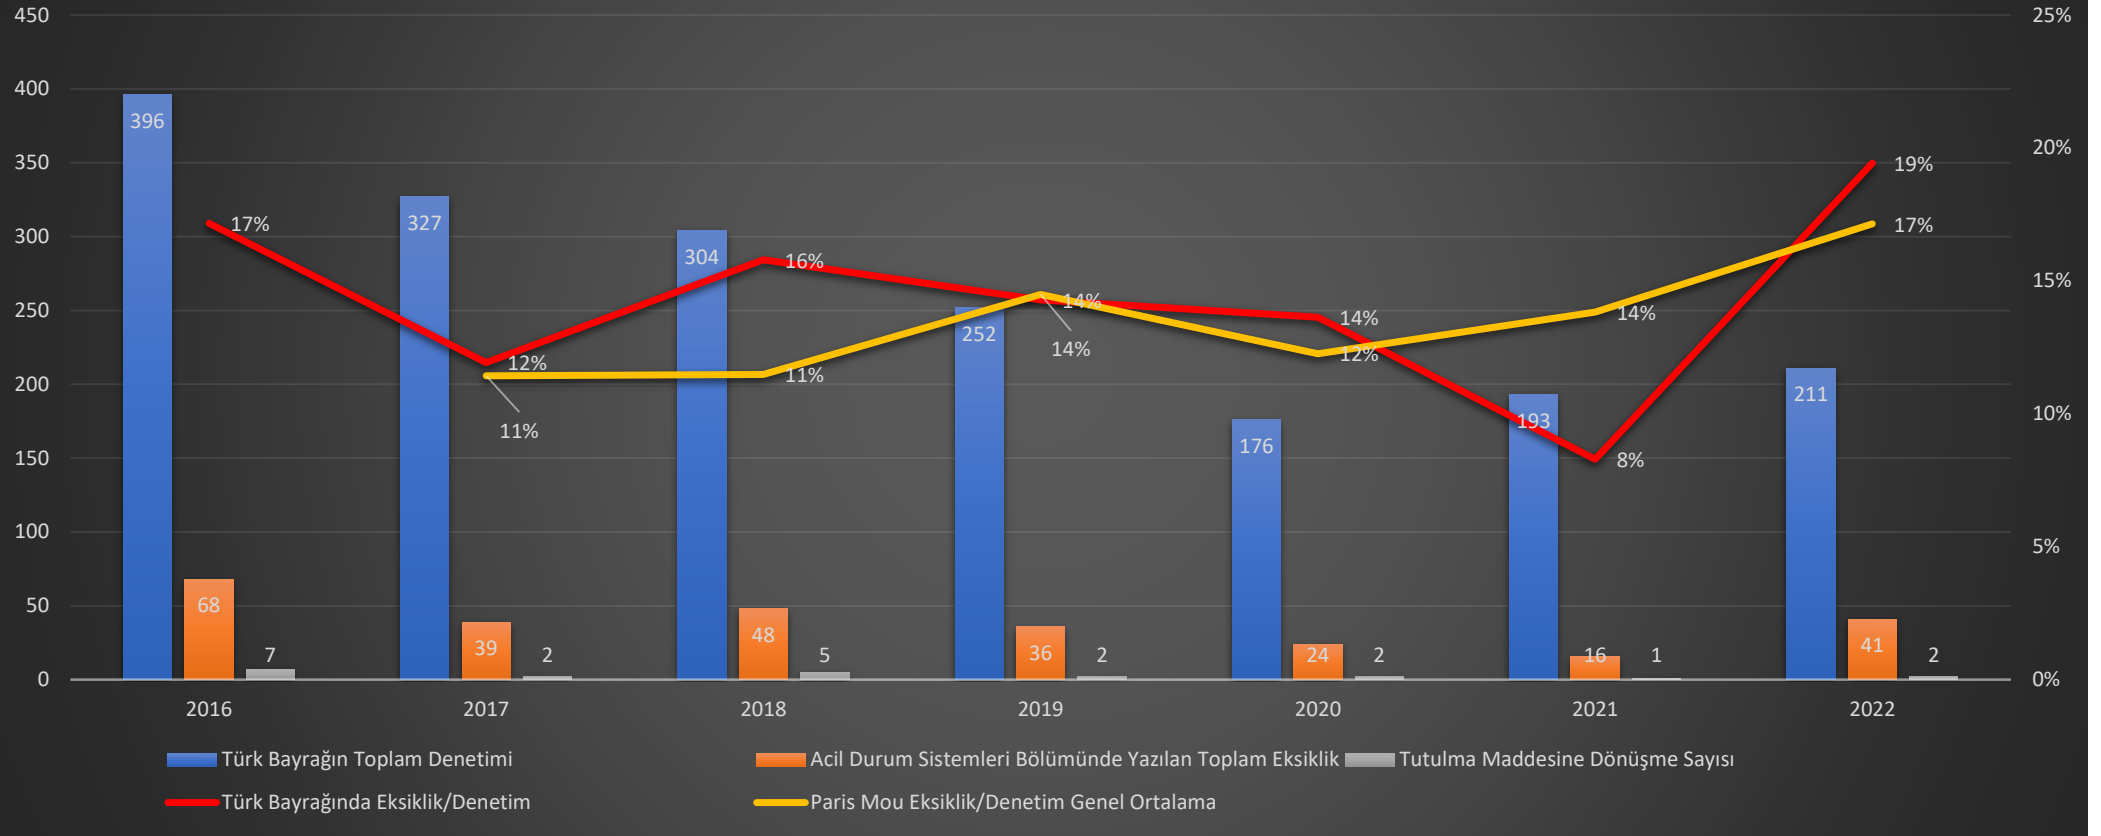
Paris Mou Kapsamında Türk Bayraklı Gemilerde Acil Durum Sistemleri

"Acil Durum Sistemleri" alanında gemilerimizin Paris MoU eksiklik ortalamasında oldukları görülmektedir.

Tespit edilen eksiklerin tutulma maddesi olarak değerlendirilmesi nedeniyle önlem alınması gerekmektedir.
